CONDITIONS OF COAL ASH EMBANKMENTS

**John Seymour¹, P.E., Omer Bozok¹, Amanda Hughes¹, Ph.D.,
Brad Bodine¹, P.E., CHMM**

CONFERENCE: 2015 World of Coal Ash – (www.worldofcoalash.org)

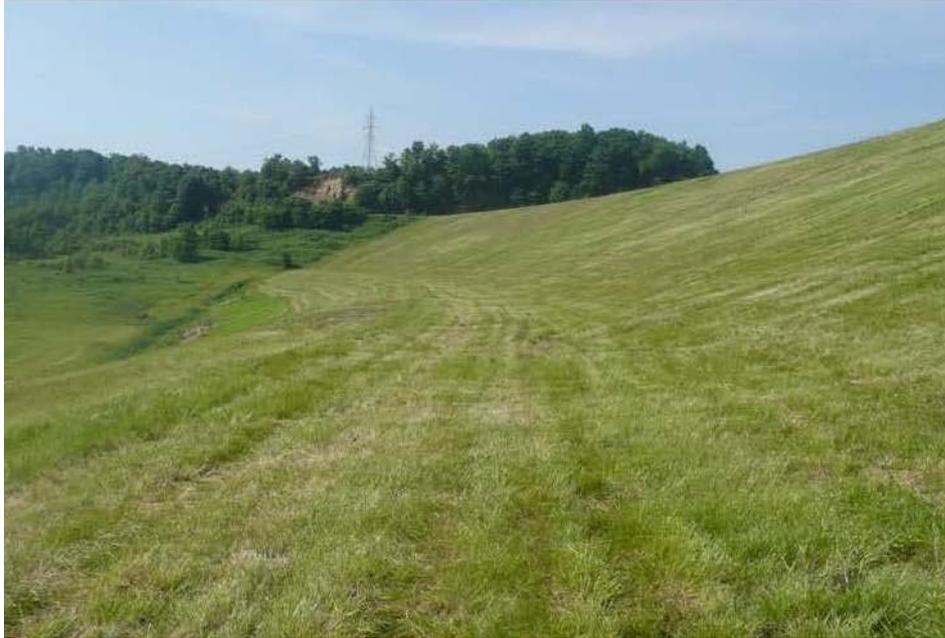
An example of the height of a 145-ft high, fly ash pond, earthen embankment and downstream slope are shown in Figure 4.

Figure 4. An example downstream slope of a fly ash pond earthen embankment.²

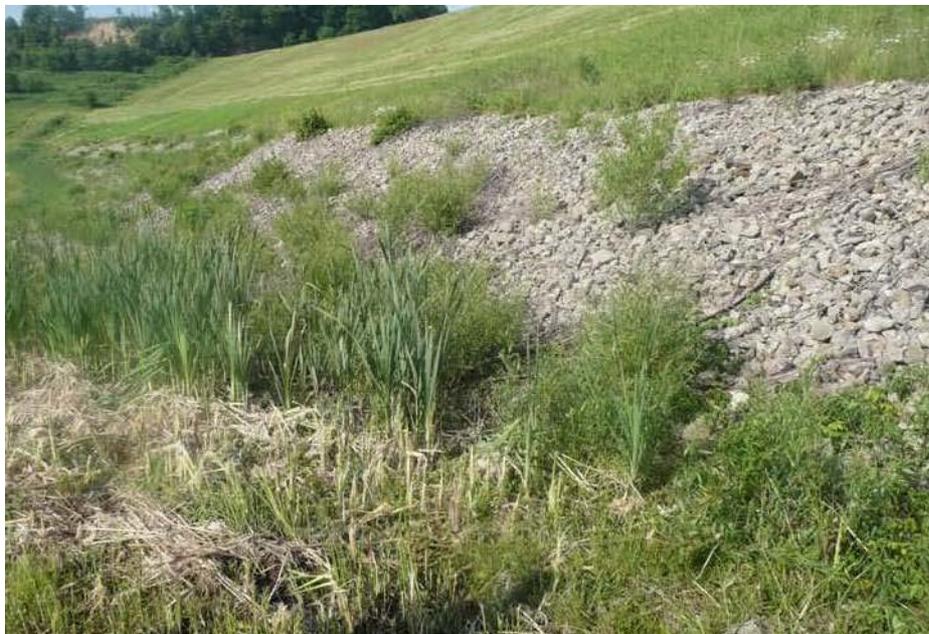
An example of evidence of seepage is shown in Figure 8 and a slough is shown on Figure 9.

Figure 8. An example of perennially wet ground and cattails from seepage.²

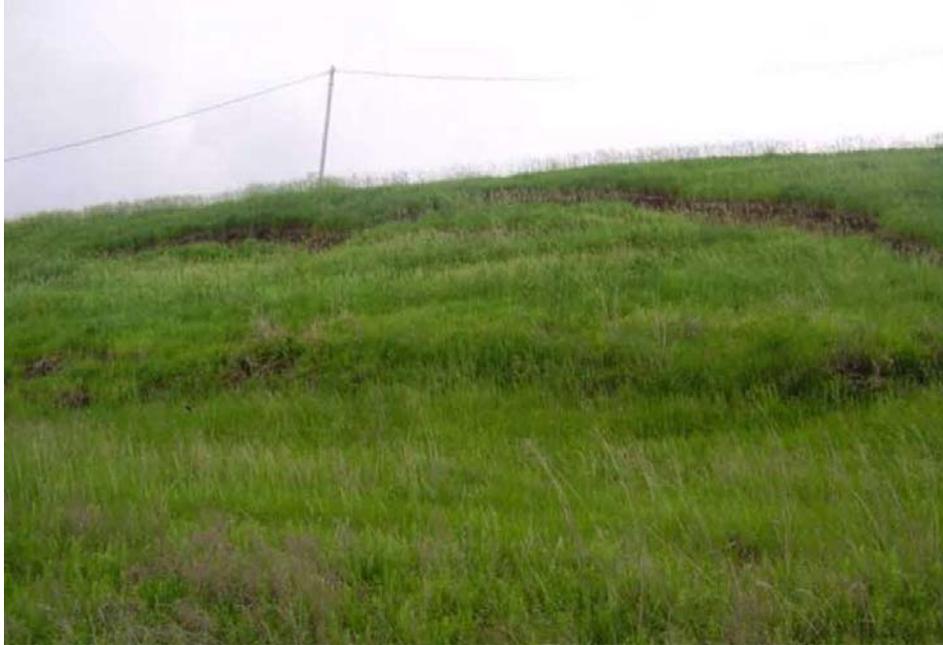
Figure 9. An example of a slough/scarp.³

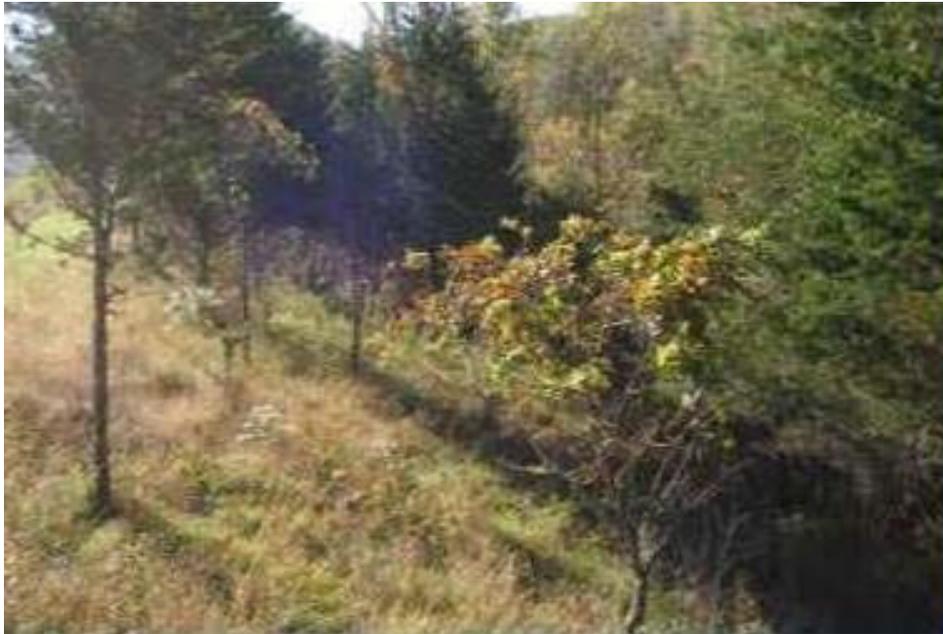
An example of woody vegetation on embankment slope is shown on Figure 11.

Figure 11. An example of woody vegetation on a downstream slope.⁴

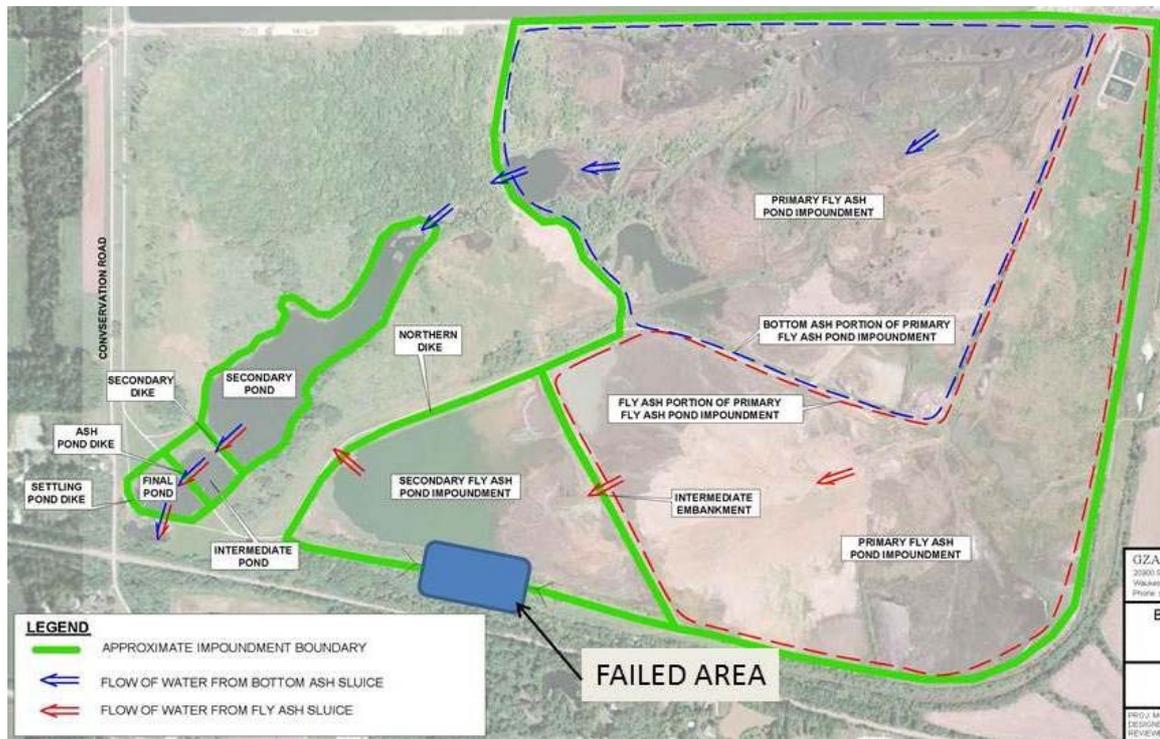
Figure 13. Baldwin Facility Site Plan³, with highlights by the authors

The Baldwin Ash Pond Facility had a deep-seated embankment failure in 1995. The facility is located in Baldwin, Illinois. An aerial view is provided in Figure 13. The embankment was reported to be constructed using “earth fill” and “impervious fill” that is presumed to be locally obtained loess deposits and low plastic clay, respectively. The embankment was originally constructed to be 35-ft high and later was vertically extended with a 20-ft dam rising. The raised embankment was constructed out of clayey soil over bottom ash and with no offset from the original embankment.³

The downstream side slope of the embankment where the failure occurred was 3H:1V. Failure analysis indicated that the failed section of the embankment had a factor of safety less than the generally expected value of 1.5. No further information was provided.

Of the key characteristics, “evidence of seepage or sloughing” and “major erosion or slope deterioration”, were identified at the facility in the USEPA inspection. If those features existed before the failure, they would have been an indication of a higher potential for failure.

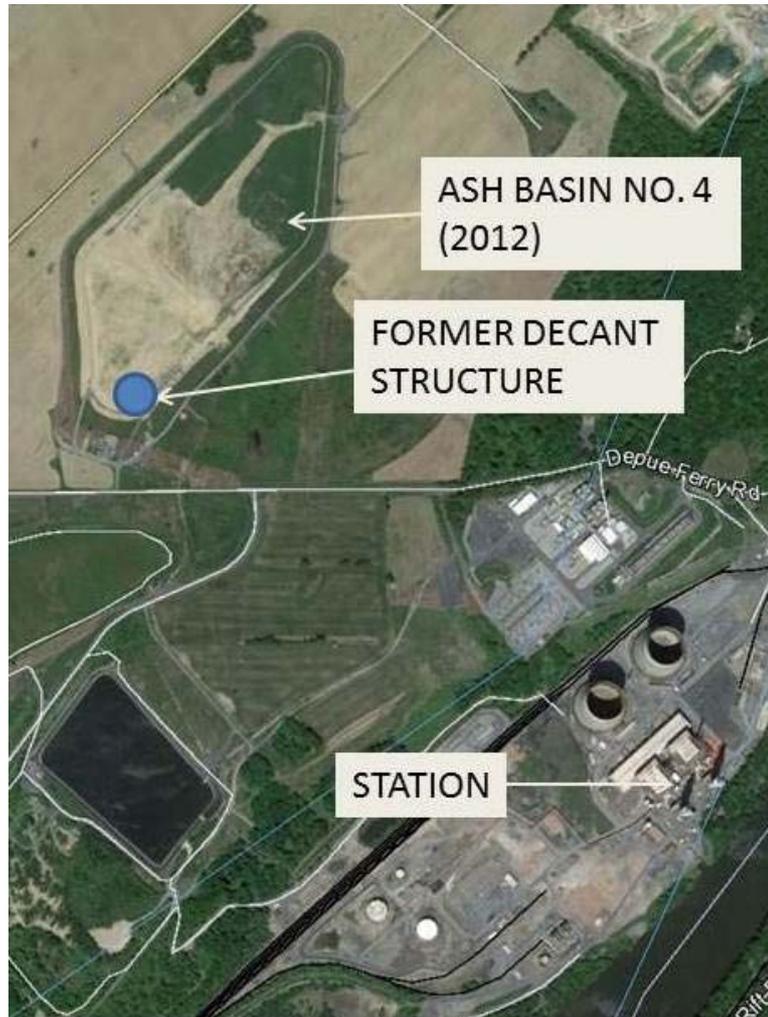
Figure 14. Martins Creek Site Plan.
Source: Google Earth, imagery date 5/19/2012

The Martins Creek Steam Electric Station Facility is located in Martins Creek, Pennsylvania. An aerial view is provided in Figure 14. The facility had four CCR treatment and disposal ponds that were utilized for disposal of CCRs. In 2005, an incident occurred where a discharge water system failed causing a significant release of water and fly ash. The mixture of water and fly ash spread into surrounding fields, into Oughoughton Creek and the Delaware River. The coal fired units have been retired since 2007 and the ponds were decommissioned.

The cause of the failure was reported to be a failed wooden stop log, which was reported to have had a fabrication defect. The stop log was the second (out of forty) from the bottom and is presumed to normally have been submerged. Once the stop log failed, there was no shutoff valve in the discharge pipe or other secondary barrier to prevent the spill or slow the release. The failure of the stop log caused an uncontrolled release of approximately 100 million gallons of fly ash slurry over three day period⁵. USEPA considered this incident as a proven damage case based on the results of an environmental study conducted after the failure. It is reported the response action cost approximately \$37 million.⁶

It appears that the failed stop log could only have been visually inspected using a remote underwater video camera. If it could have been observed, the defect would likely not have been detected through visual observation by remote camera inspection. It appears that none of the typical inspection characteristics

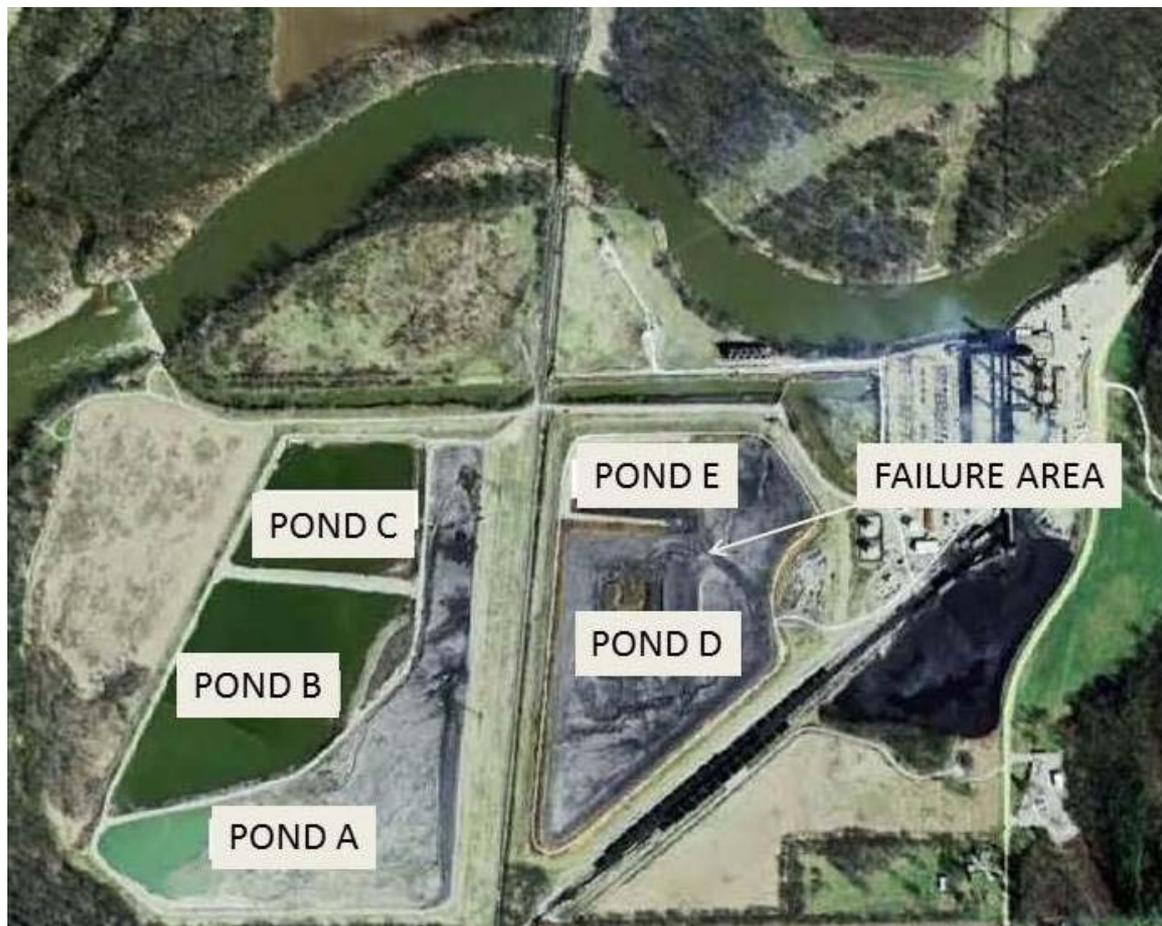
Figure 15. Eagle Valley Site Plan⁷, with highlights by the authors

The embankment was designed and constructed with generally 3H:1V slopes. Embankment failures occurred at the facility in 2007 and 2008. Both failures occurred in the same embankment separating Pond D and Pond E. The Reports indicate that the failed embankment was made of fly ash. The containment embankments were reported to be constructed of “compacted fill & ash” or “earthen/ash”. These two failure events are considered one failure because they occurred at the same location.

In 2007, the embankment between Ponds D and E failed causing Pond D to flow into Pond E causing the northern embankment of Pond E to overtop, releasing 30 million gallons of treated pond water into the discharge canal. A similar failure occurred in 2008 at the same location causing another 30 million gallons of treated pond water to spill into the discharge canal.

The cause of the 2007 failure was reported by BT Squared to be slope instability combined with piping (seepage that carries or erodes soil particles from within the embankment) through the embankment (CDM 2010). The cause of the 2008 failure was reported by BT Squared to have resulted from an overestimation of the shear strength of fly ash by the designer and the redesigned embankment was inadequate to support the loading conditions on the embankment between Pond D and Pond E.⁷

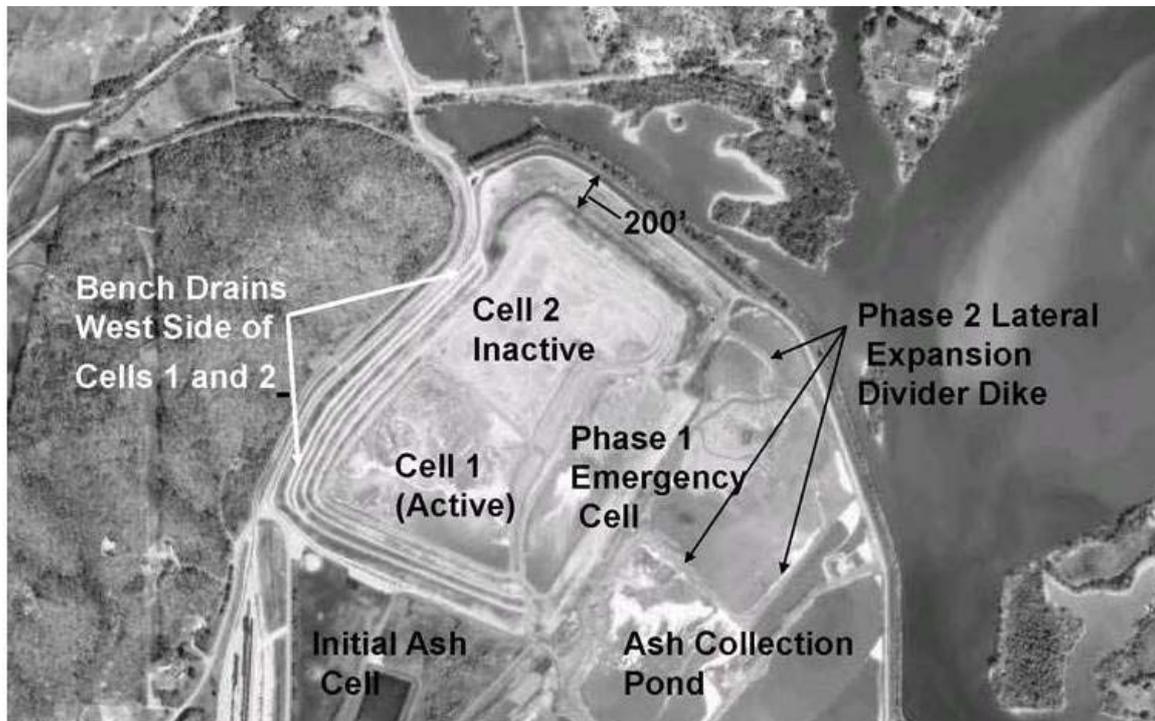
Figure 16. Kingston Dredge Cell Site Plan (2008).¹

The Kingston Fossil Plant Facility is located in Harriman, Tennessee. An aerial view is provided in Figure 16. It had two main CCR handling areas: (i) Ash Pond C, used for treating and storing fly ash and bottom ash; and (ii) the FGD Landfill, used for storing FGD sludge. In addition to Ash Pond C and the FGD Landfill, the plant had a dredge cell to store fly ash (currently decommissioned due to the failure in 2008). The dredge cell had received CCR in the form of slurry until it reached its capacity in the early 1980s, after which the dredge cell was vertically expanded by constructing elevated cell containment embankments primarily out of ash. The expansion embankment was set back a minimum of 200 ft from the main embankment surrounding the dredge cell. The facility underwent a number of subsequent raisings of the containment embankment using the upstream construction method.

In 2008, the dredge cell had a major failure in the northern portion of the site causing an uncontrolled release of approximately five million cubic yards of ash slurry that flooded more than 300 acres of land, impacted the Emory River and Clinch River, disrupted power, ruptured a gas line, knocked one home off its foundation and damaged others. Fortunately, there were no casualties. The failure caused the largest ash release in the United States.

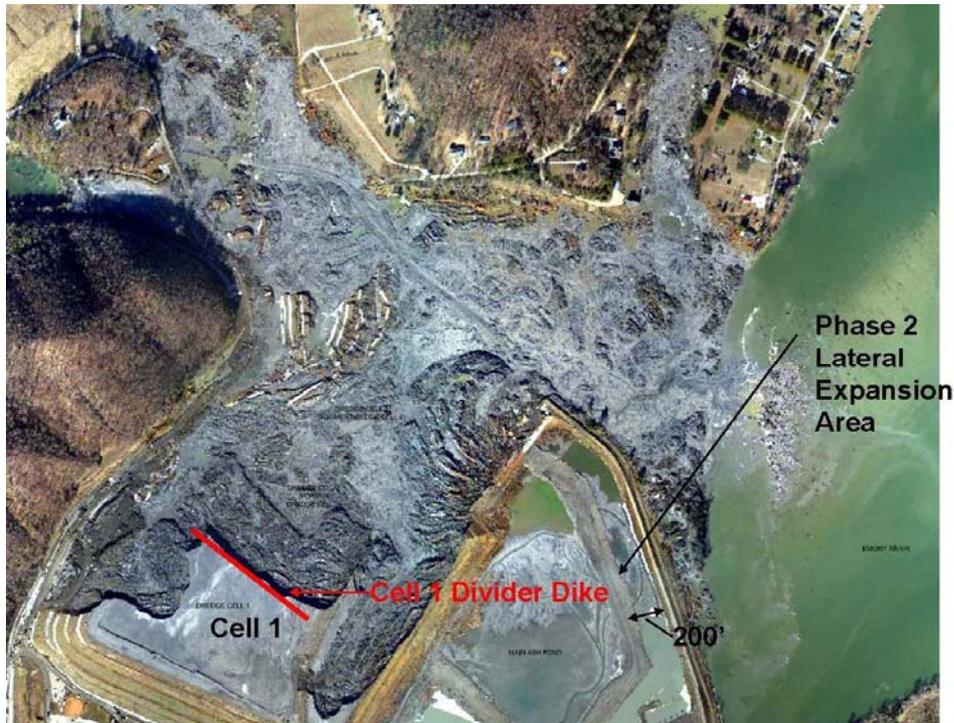
Figure 17. An aerial view of Kingston Dredge Cell 2 Failure¹

The release occurred as a result of a series of progressive failures of dredge cell containment embankments that were constructed as part of vertical expansions of the dredge cell. The dredge cell containment embankments failed over a period of hours. It was reported that several factors lead to failure, including: i) the relatively fast rate of vertical expansion; ii) the nature of loose wet ash foundation materials below the containment embankments; iii) fill setback and geometry, and iv) unusually weak slimes layer located under the raised dredge cell containment embankments.⁸ The cost of failure is estimated to be approximately \$3 billion including the cleanup cost and ecological and socio-economic damages.⁶

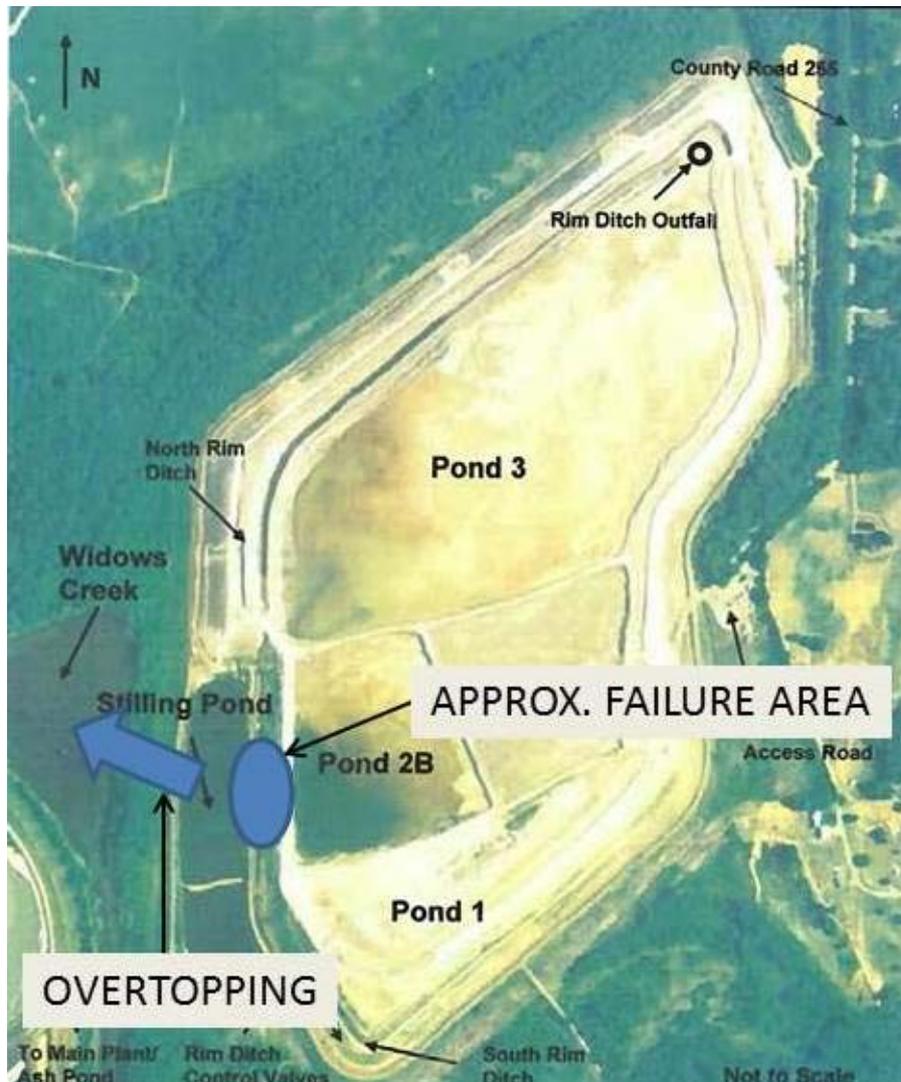
Figure 18. Widows Creek Site Plan.⁹ (Appended Stantec February 2010 Report of Phase 2 Geotechnical Exploration) with highlights by the authors

There were two incidents that occurred at the facility, one in 2009 and one in 2010, each causing an uncontrolled release of gypsum. In 2009, an abandoned weir from an internal drainage system failed releasing gypsum into the gypsum stack stilling pond and into Widows Creek.⁹ Approximately 6.1 million gallons of slurry carrying approximately 5,000 cubic yards of gypsum and some fly ash was released into Widows Creek which flows into the Tennessee River. The cleanup cost for the 2009 incident was reported to be approximately \$9.2 million.⁶ USEPA did not classify this incident as a damage case, because samples at relevant points of potential exposure did not exceed applicable standards.⁹

It appears that none of the typical inspection parameters included in this analysis would have been a precursor to failure. However, checklist question 21 provides related information on seepage, including whether seepage is coming from “Around the outside of the decant pipe”. While it was an “abandoned weir” from an internal drainage system that failed and not a decant pipe, it could be presumed that an experienced inspector would have noted seepage from around the weir if it was on the inspection checklist.

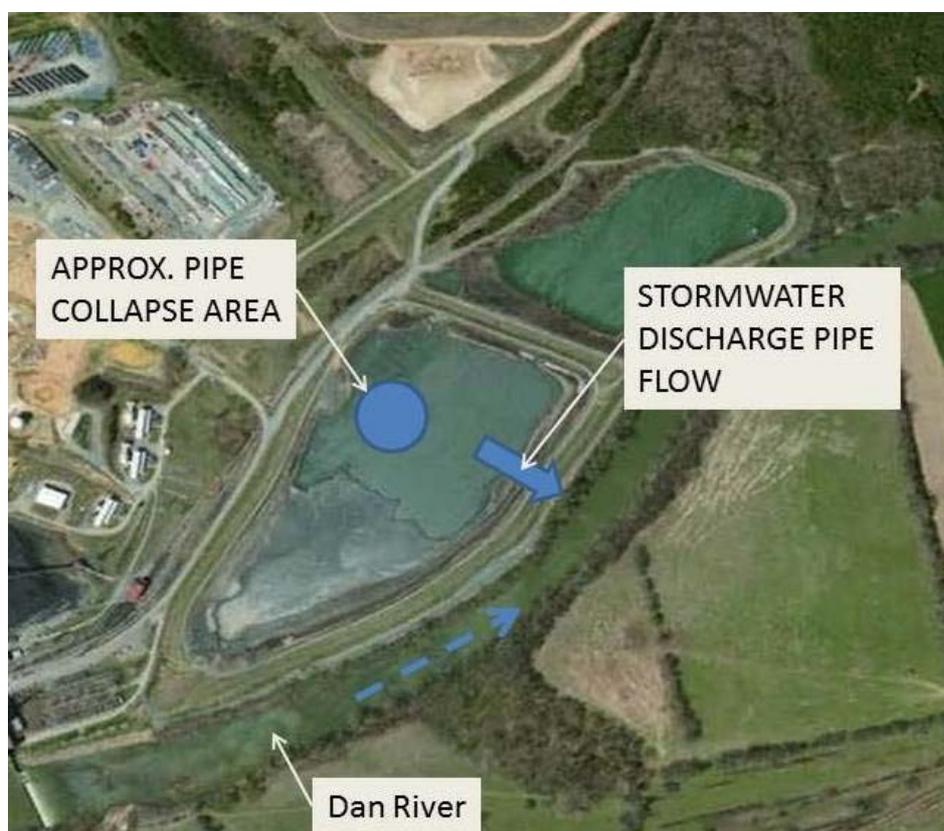
Figure 19. Dan River Site Plan,¹¹ with highlights by the authors

In February 2014, a portion of the 48-in stormwater pipe under the Primary Pond collapsed¹¹, causing approximately 30,000 to 39,000 tons of ash to drain into the Dan River. A timeline of events is presented here:

Visual inspection of the collapsed pipe performed after the failure revealed that portion of the pipe where the pipe collapsed was corrugated metal pipe. The rest of the pipe was concrete¹¹.
