# Twenty-Five Years' Experience Operating a HDPE Lined Twin Pond Ashing System

**Ken Keam<sup>1</sup>**

CONFERENCE: 2015 World of Coal Ash – ([www.worldofcoalash.org](http://www.worldofcoalash.org))

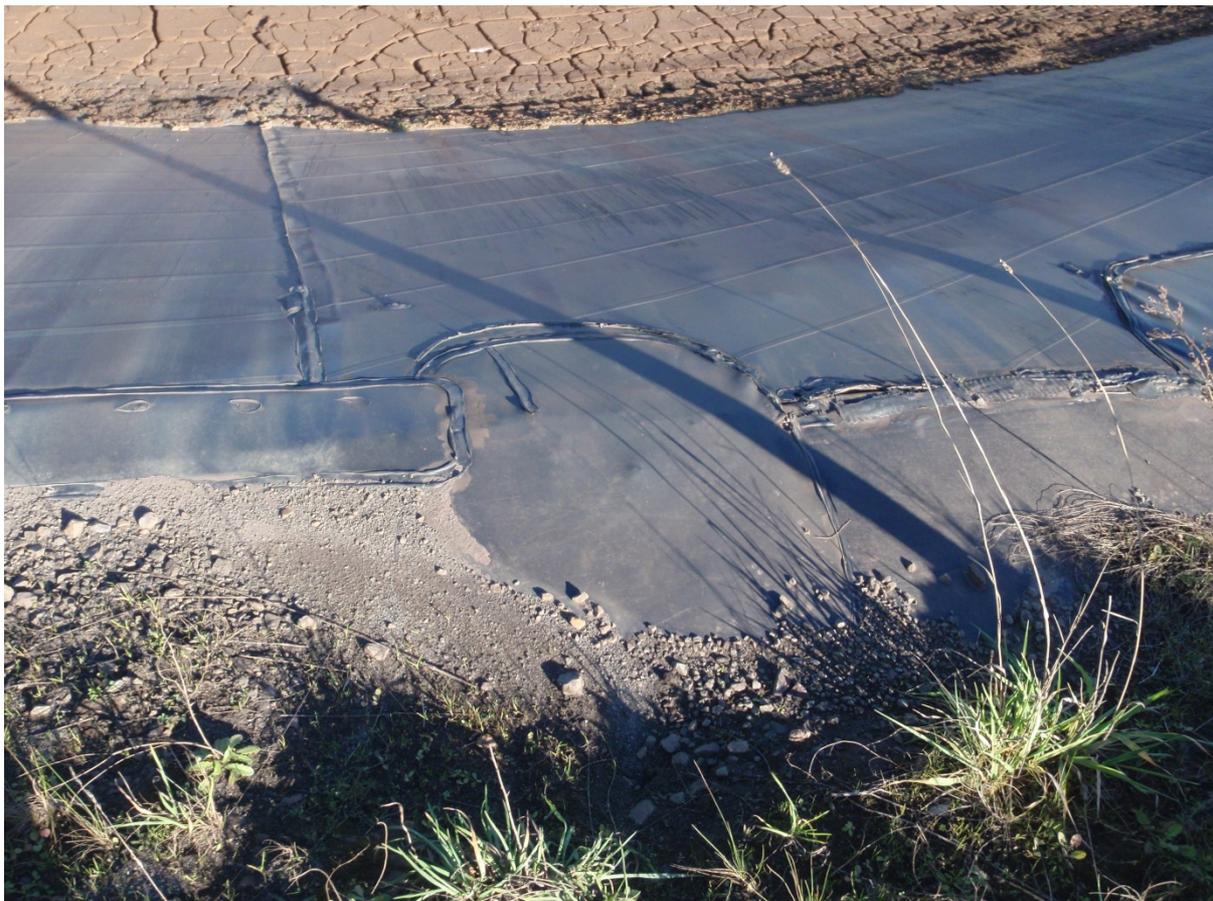
From the time of the first excavation cycle liner damage on the walls during ash excavation became a significant problem. For example, the liner inspection following the routine excavation of the ash from the northern pond in 1989 revealed 10 cuts to the liner but in 1991 revealed over 120 cuts to the liner walls. These were repaired prior to re-commissioning the pond. The following year after a 1 m layer of ash was left against the wall only three holes were identified and repaired in the southern pond. However the following year there were 21 holes in the northern pond liner after the ash excavation.

**Figure 11– Damage and repairs to the liner on the crest of the batter.**

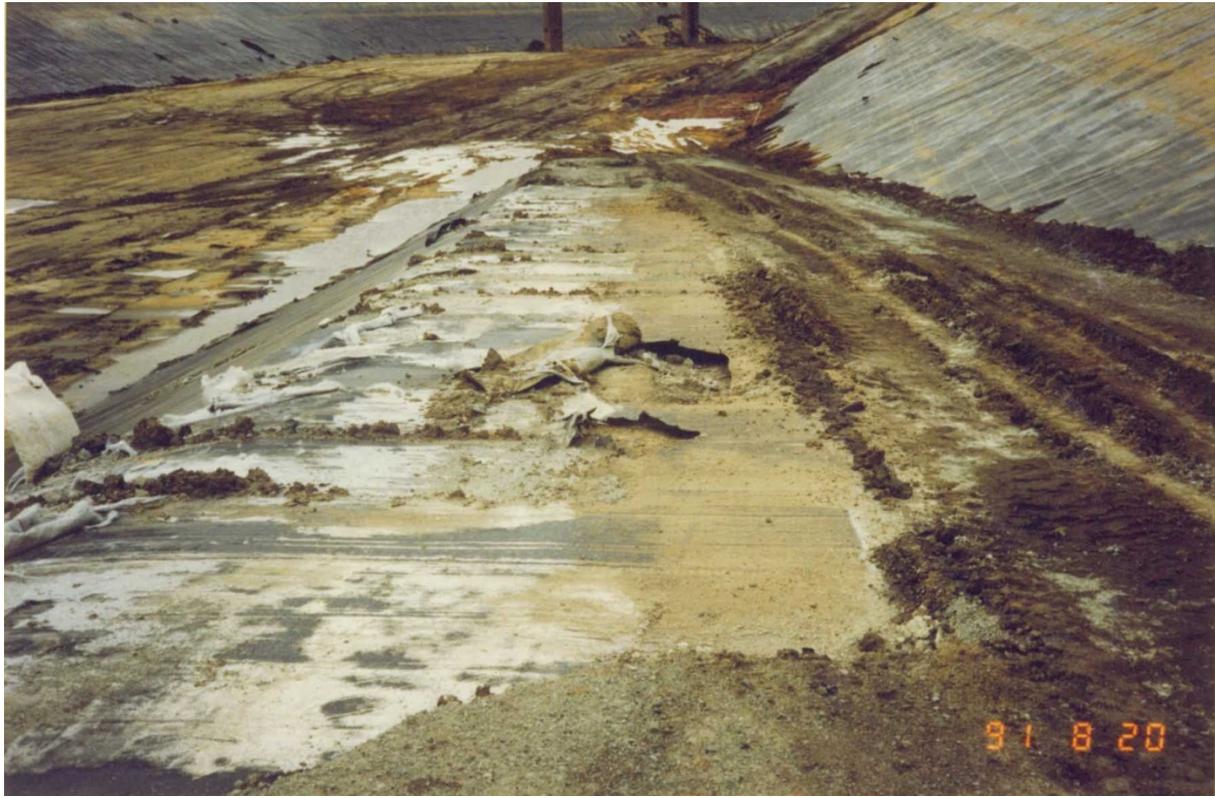
**Figure 12 – Damage to liner on the ramp**

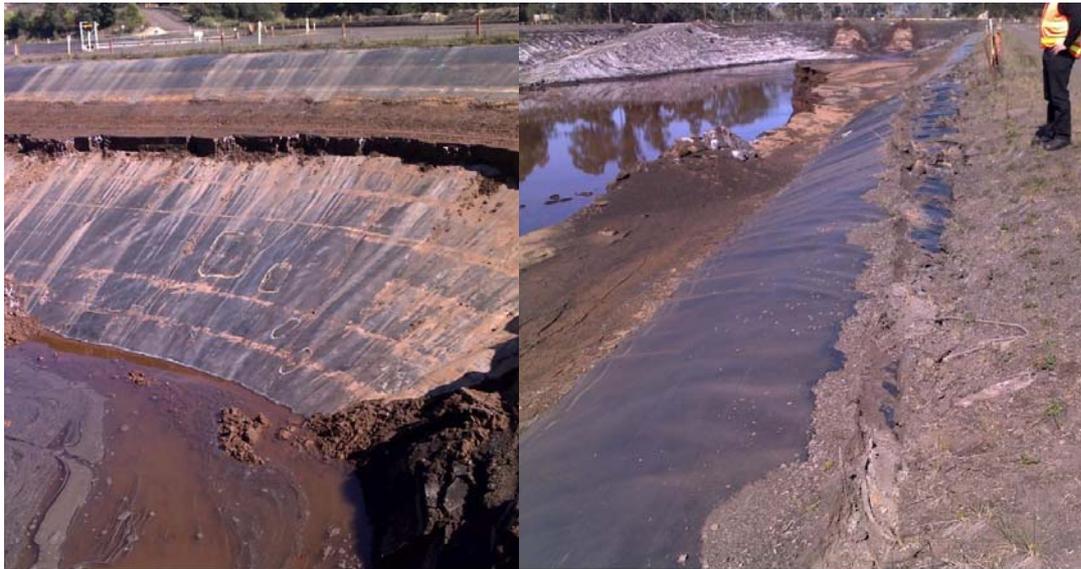
In October 2010 a liner slippage occurred in Pond No.2 towards the centre of the central embankment. The liner had been pulled out of the anchor trench and slipped approximately 200 mm down the face of the embankment. This is shown in Figure 13. Again the suspected cause of the liner slippage was that large wedges of ash were left on the batter during the excavation process which overstressed the liner. The liner was

**Figure 13 –Liner pulled from trench**

lifted to its original position and a new piece of liner welded over the top. The new liner was anchored into a new trench behind existing anchor trench.

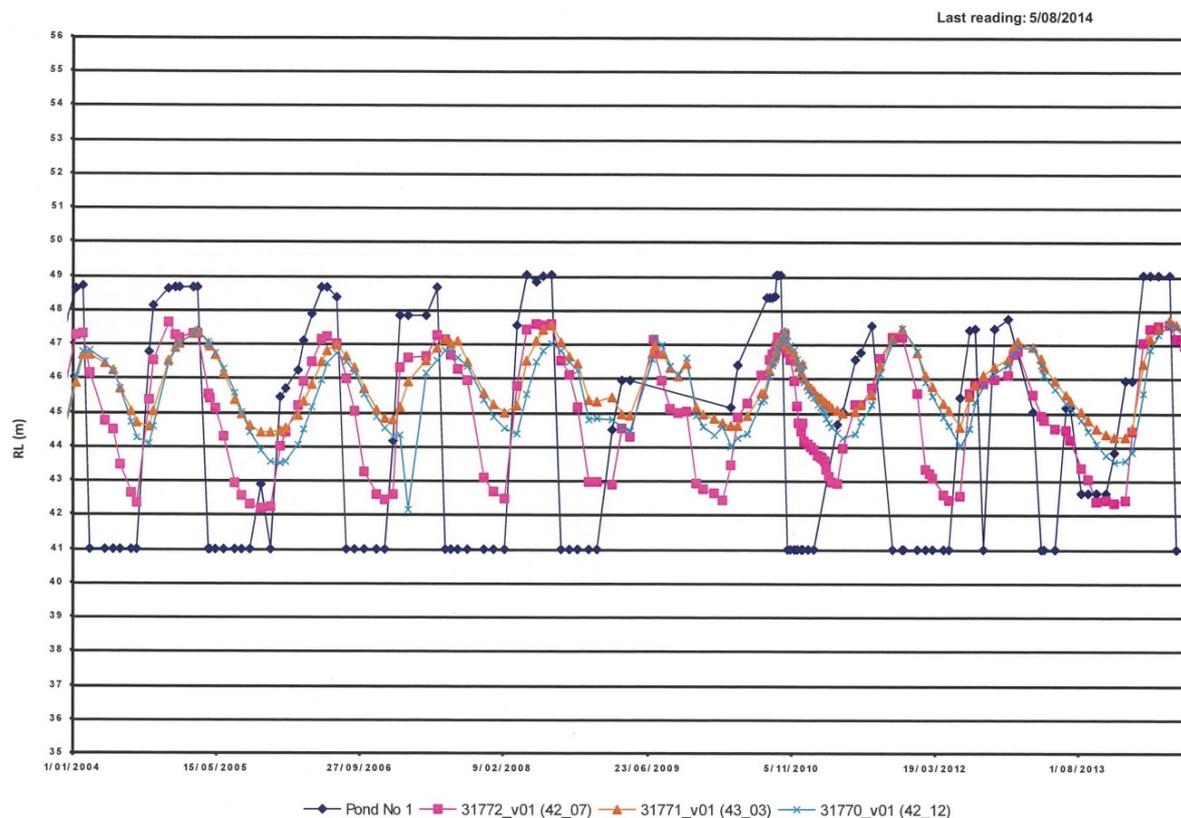
The piezometer monitoring shows elevated water pressures behind the liner at the eastern end of the ponds that respond directly to the level of ash water in the pond. This is considered to be due to cuts in the liner and the blockage of the sub-surface drains beneath the liner at the toe of the batter. Repairs to the liner have locally provided temporary relief but the overall trend continues. This behaviour is shown in the piezometer plot Figure 14. It can be seen that the measured groundwater level behind the liner peaks when the pond levels starts to drop. The rapid drawdown of the pond water level at the commencement of the drainage cycle has led to excess pressure behind the liner causing batter slumping and subsequent liner damage.

**Figure 14 – Piezometer readings at eastern end of the ponds**

To maintain the stability of the batters during pond drainage it has been necessary to leave an upstream toe weighting berm approximately 9 m wide and 4 m high comprised of ash during excavation around the affected areas of the ponds as shown in Figure 7. These have been designed to maintain an acceptable factor of safety but reduce the storage capacity and cycle times of the ponds.

As a long term solution to reduce the groundwater pressure beneath the liner it is proposed to install dewatering wells in the embankments adjacent to the liner. It is expected that this will reduce the risk of embankment slumping following dewatering and restore the full capacity of the ponds.

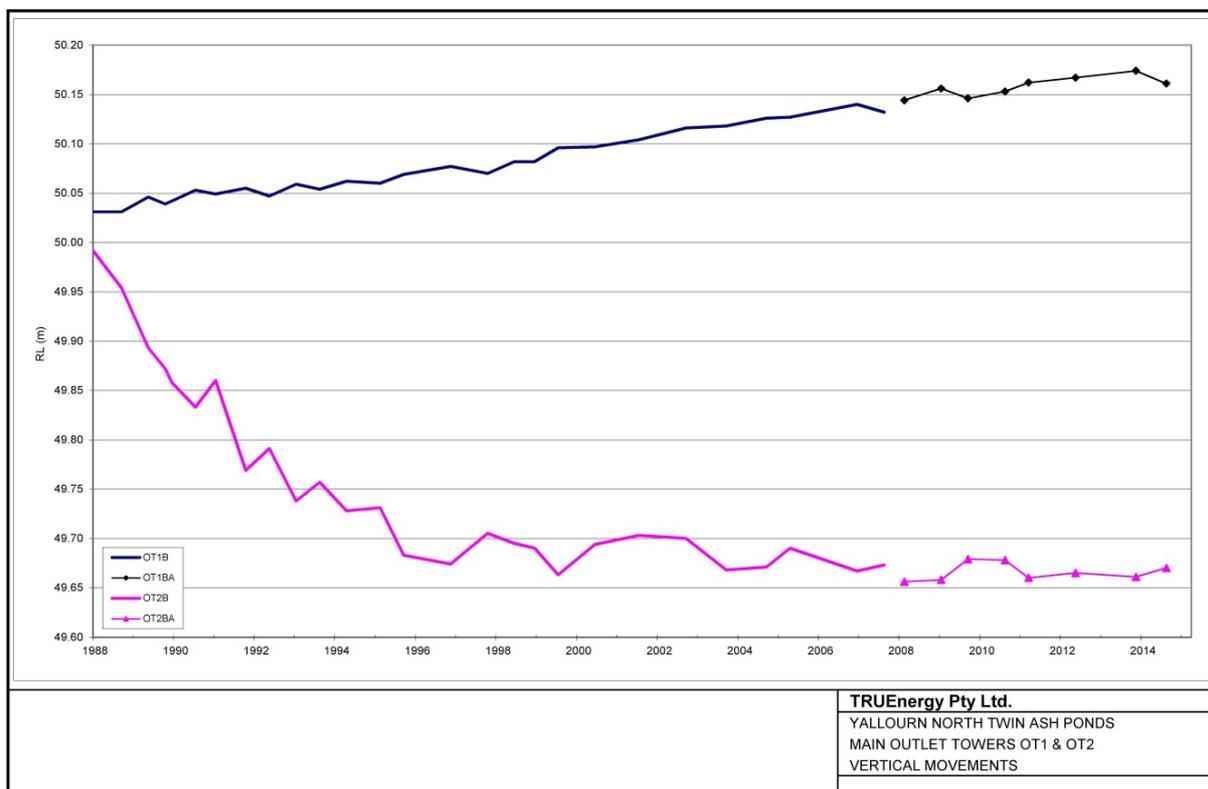
The surveyed outlet tower in Pond No.2 has shown a horizontal movement since 1987 of approximately 280 mm in the southerly direction. It settled approximately 330 mm up until 1997 and has since fluctuated by approximately 30 mm with filling and emptying cycles.<sup>4</sup> The vertical movements for these towers are shown in Figure 15.

**Figure 15 – Graph of Outlet Tower vertical movement**
