# Effects of Acid Mine Drainage on CCP Grout: A Bench-Scale Weathering Experiment

**Nathaniel Warner<sup>1</sup>, Joseph Giacinto<sup>1</sup>; Gary Reeves<sup>2</sup>, Amy Albright<sup>2</sup>; and Paul Petzrick<sup>3</sup>**

<sup>1</sup>ERM, 200 Harry S. Truman Pkwy., Annapolis, MD 21401; <sup>2</sup>Western Maryland Resource Conservation Council, 18450 Showalter Road, Suite 111, Hagerstown, MD 21742; <sup>3</sup>Maryland Department of Natural Resources, Power Plant Research Program, Tawes Office Building, B-3, Annapolis, MD 21401

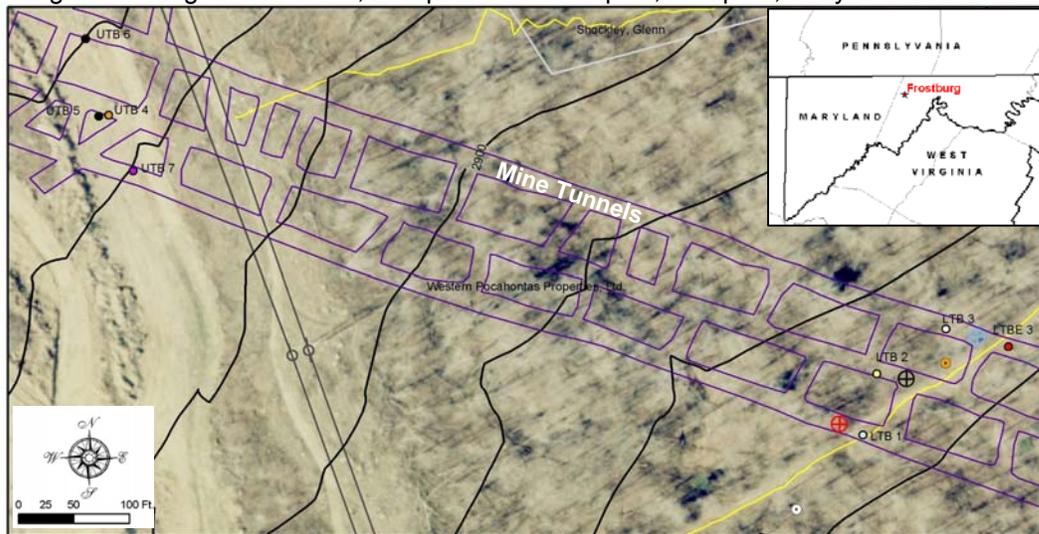
Figure 1. Siege of Acre Site, Kempton Mine Complex, Kempton, Maryland.

The Siege of Acre segment of the Coketon/Kempton Complex is in the northern extremity of the mine workings in Maryland (Figure 1). The proposed Siege of Acre project focuses on three isolated, parallel tunnels, each 16 feet wide, that run “up dip” from the northern edge of the Kempton Mine Pool for approximately 230 m.

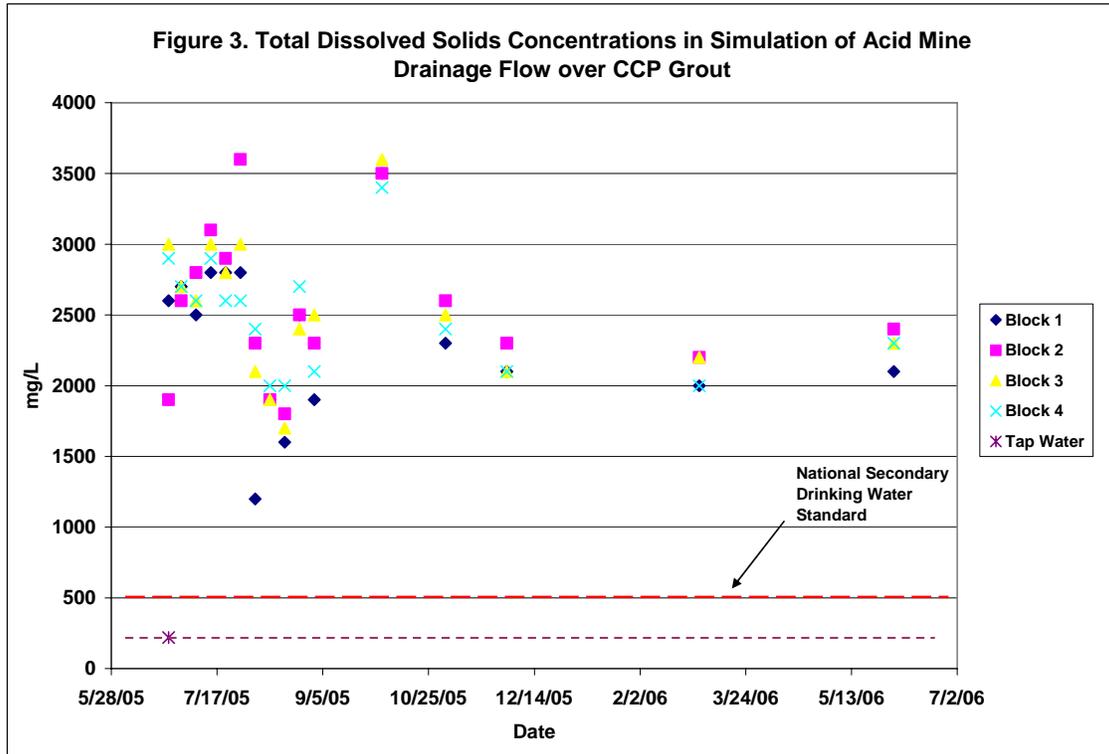
Samples of the circulating water were collected and analyzed for contaminants of concern such as sulfate and aluminum. Over a year of water quality monitoring has been conducted on the water flowing over the CCP weathering blocks. Over the first 8 weeks of the experiment, the water flowing over the blocks was sampled weekly, followed by monthly sampling for 3 months. Currently the sampling has been reduced to quarterly events. The results of the sampling are presented below in Figures 3 through 10. For a baseline comparison, the concentrations of each constituent are also shown for the tap water that was used to form the solutions. Initially, total dissolved solids (TDS) concentrations increased over an order of magnitude above the original tap water before stabilizing (Figure 3).

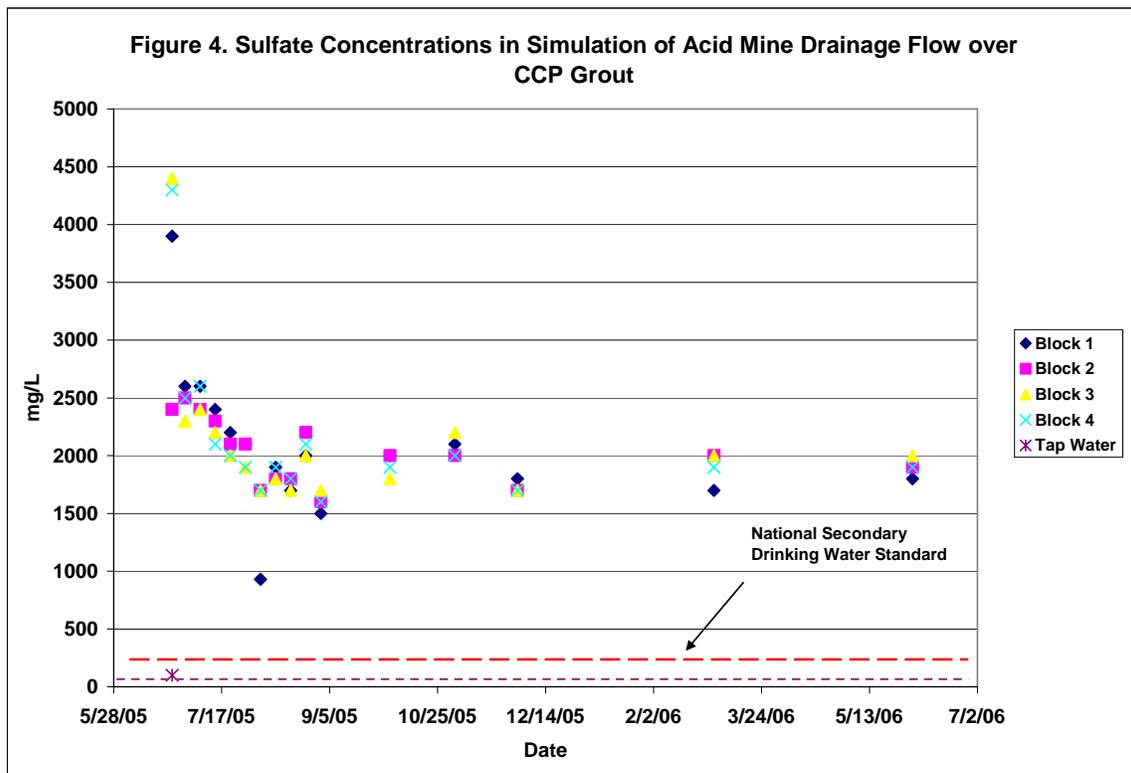
The majority of the TDS (approximately 2,300 mg/L) appears to be composed of sulfate (approximately 2,000 mg/L) shown in Figure 4 and much smaller proportions of potassium (100-200 mg/L) shown in Figure 5, calcium (600-800 mg/L) shown in Figure 6, and sodium (50-100 mg/L) shown in Figure 7. As with TDS, these constituents initially increase significantly over the background concentrations in tap water and then gradually stabilize suggesting that the system is approaching steady-state conditions. Similar results have been observed for the Winding Ridge Project<sup>1</sup>. Concentrations of sulfate, calcium, and potassium increased significantly after injection of the grout, but have gradually decrease (over the past 10 years) suggesting that the grout dissolution slows over time and will approach some steady state.

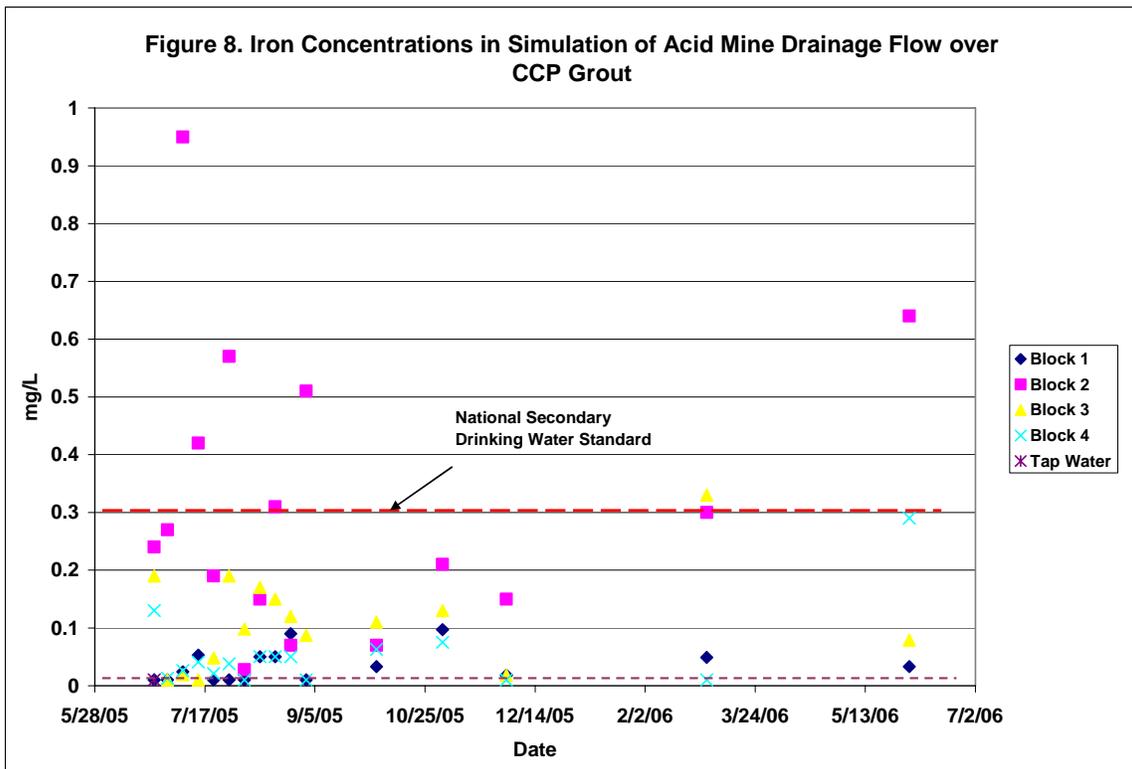
Low concentrations of iron (Figure 8) and aluminum (Figure 9) are also present in the water samples, although at concentrations that are not considered to be significant.

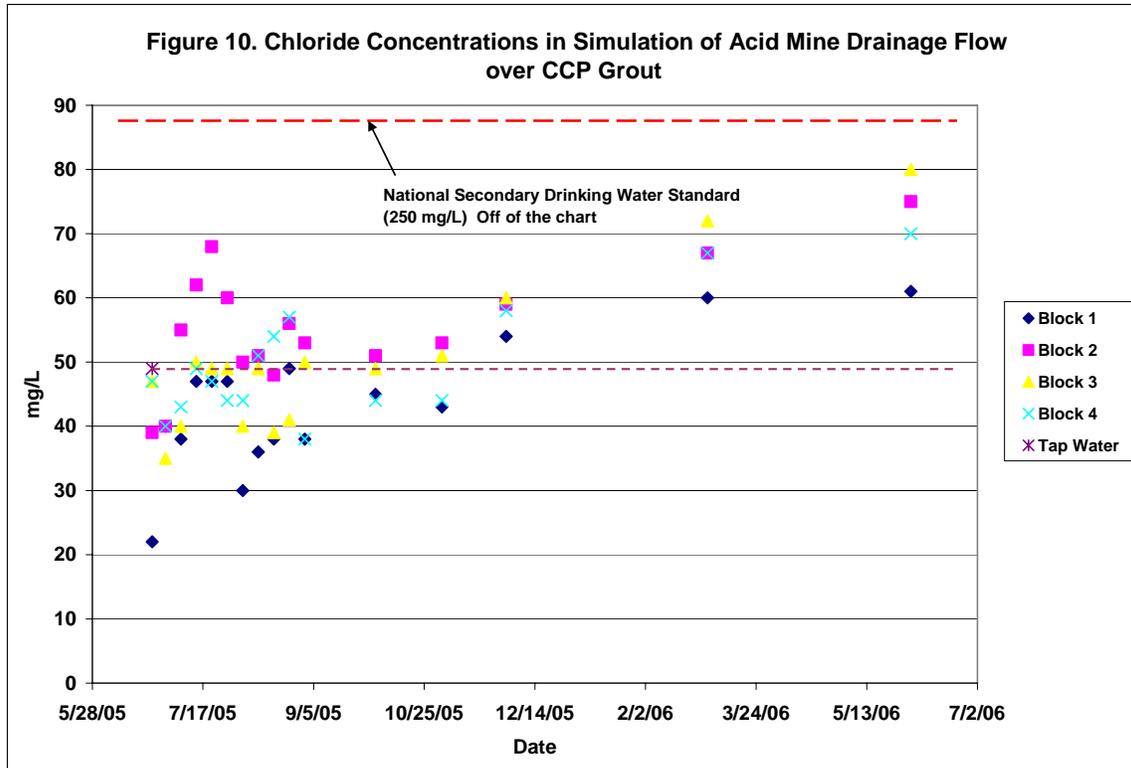
The lone exception to the decrease in constituents is chloride (Figure 10). After an initial decrease in dissolved concentration (from 50 to 20 mg/L), concentrations increased to 60 to 80 mg/L in all of the samples. While an initial increase in chloride was observed at Winding Ridge<sup>1</sup> chloride concentrations eventually decreased in the same manner as sulfate, potassium, sodium, etc. The steady increase of chloride concentrations observed in the weathering blocks was not observed elsewhere and may be an artifact of evaporation.
