Pond Closure - Case Study^[TP1]

By Pedro J Amaya, P.E. (1)

One of the options for unlined Coal Combustion Residual (CCR) impoundment facilities under the CCR regulations is the closure of the impoundment. The case study presented herein depicts the progression of the proposed closure in accordance with the design.

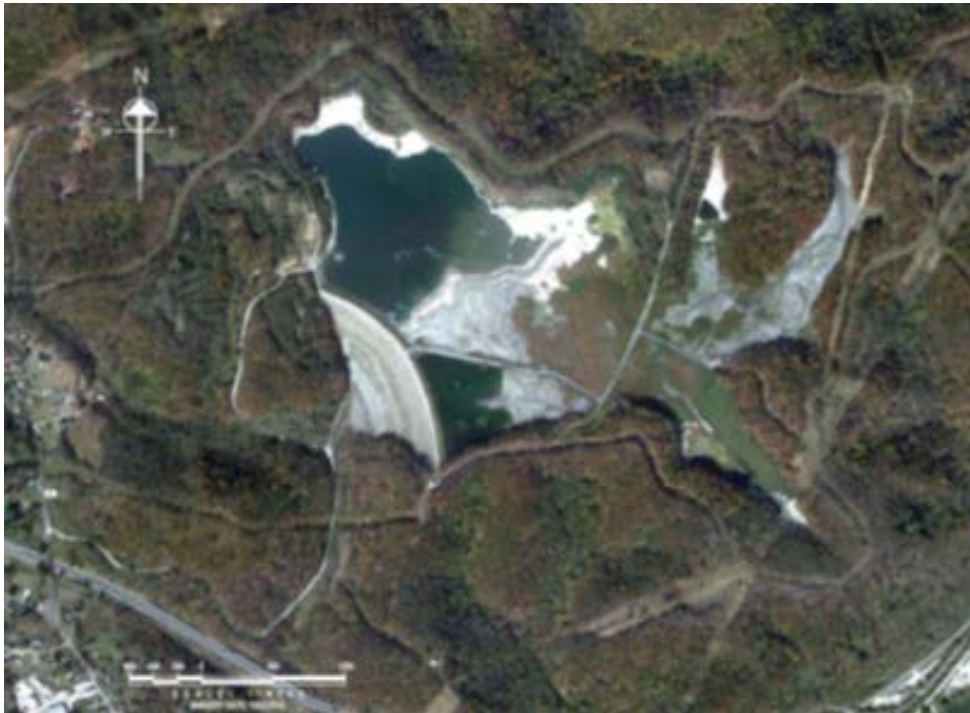
Figure 1. Fly Ash Reservoir

The fly ash reservoir being closed is located approximately 1.5 miles southwest of the power plant. The impoundment was initially created by the installation of a dam in 1973. Subsequent raisings of the dam has resulted on 220-foot high dam at the time of the proposed closure. The reservoir has a surface area of approximately 160 acres at a normal pool elevation of 858 feet, and an overall drainage area of approximately 300 acres. The impoundment has a total permitted storage capacity of approximately 11,160 acre-feet.

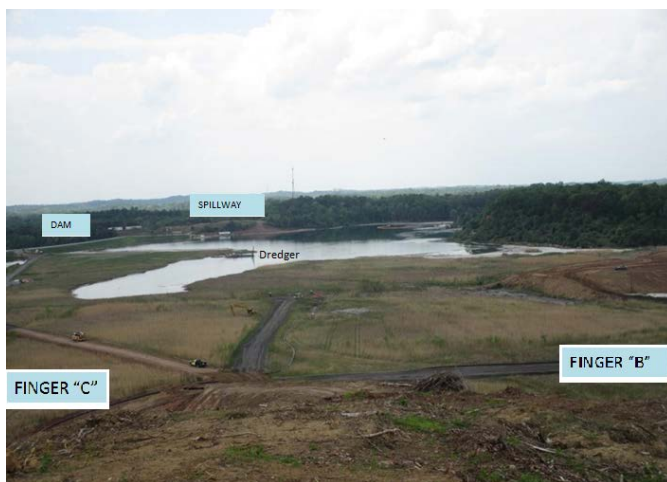
Figure 3. Initial re-distribution of fly ash.

Initial redistribution of the ash from the areas of cut to the areas of fill was accomplished by using wet dredging techniques. The removal of the free water was achieved by pumping the water from near the former outlet works to a power plant basing to be treated and discharged via a NPDES outfall. Floating roads using a cross-section that included geogrid reinforcement were built on top of the exposed fly ash with granular materials.

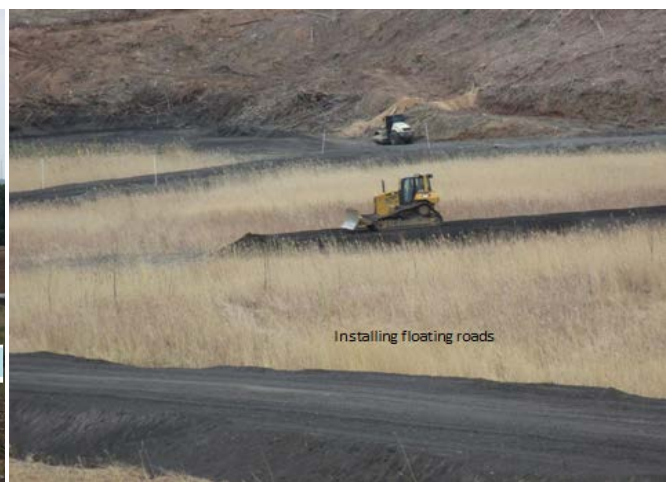
Figure 4. Installation of floating roads over exposed fly ash subgrade.

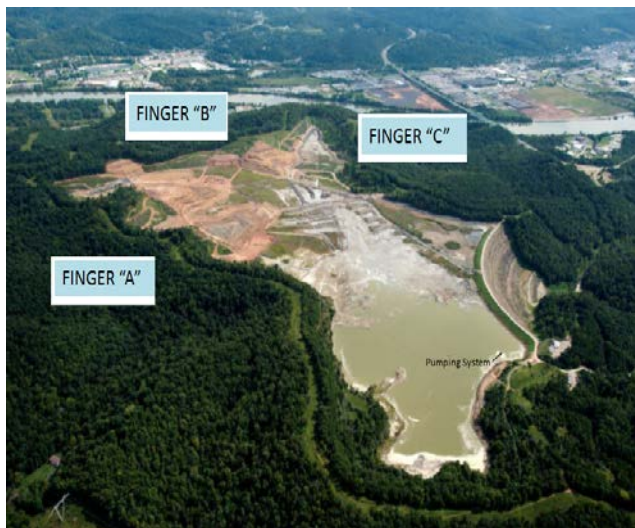
Figure 5. Free water drainage and removal.

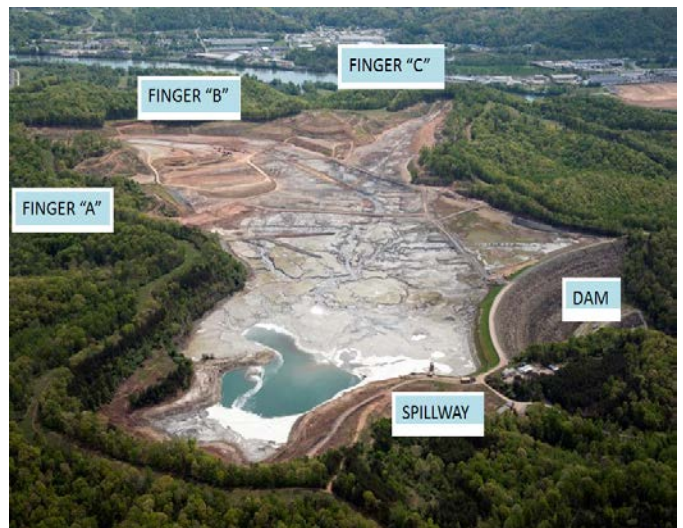
Figure 6. Floating road network and installation.

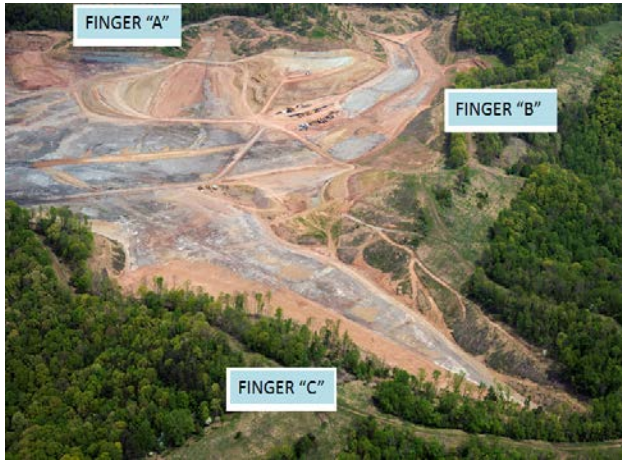
Figure 7. Installation of bridge layer over exposed fly ash surface.

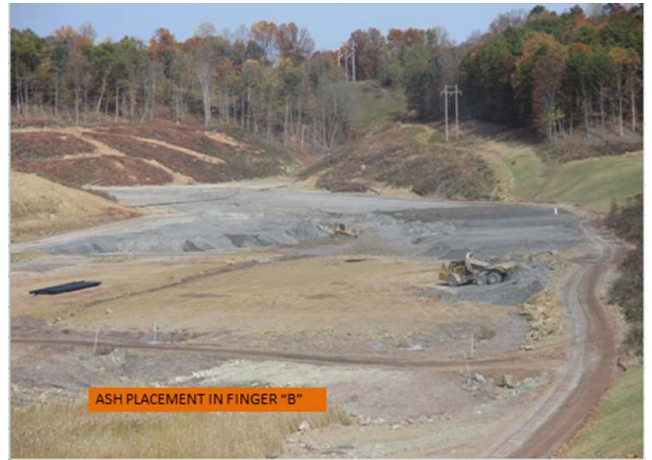
Figure 8. Placements of excavated fly ash fill to achieve desired subgrade level.

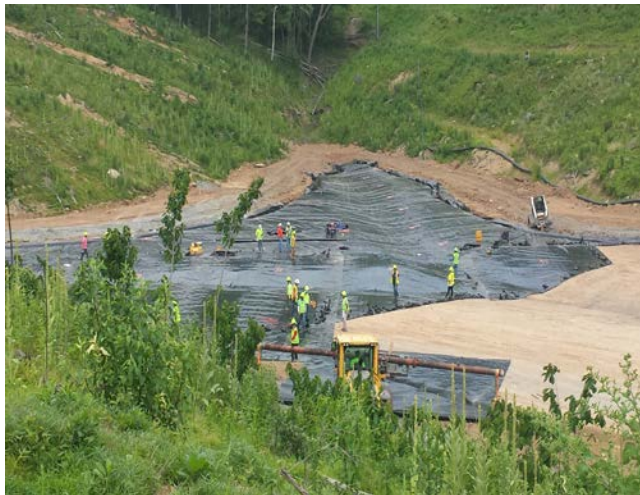
Figure 9. Liner installation

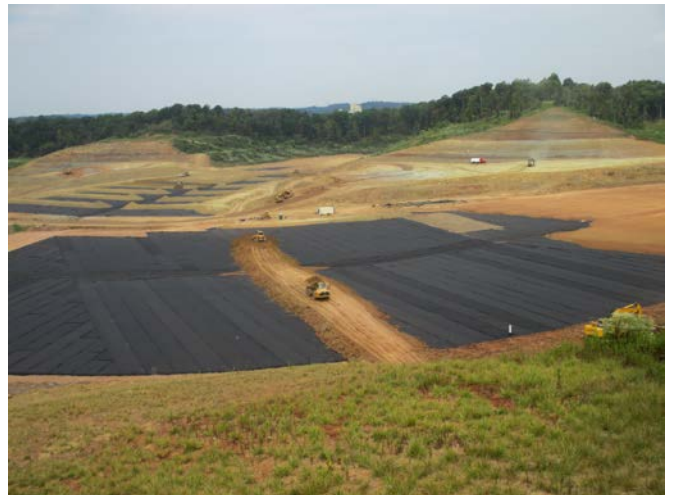
Figure 10. Installation of liner's protective cover including cushion fabric.

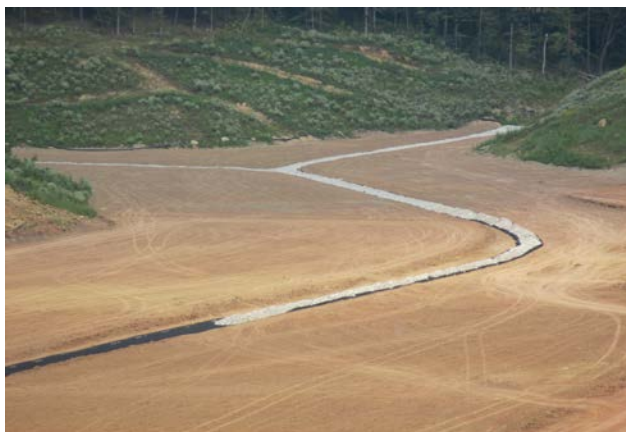
Figure 11. Conveying channel riprap revetment installation.

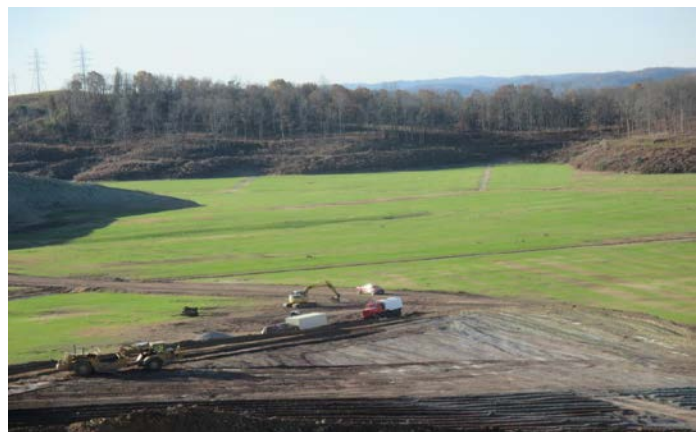
Figure 12. Vegetative cover of cap system.

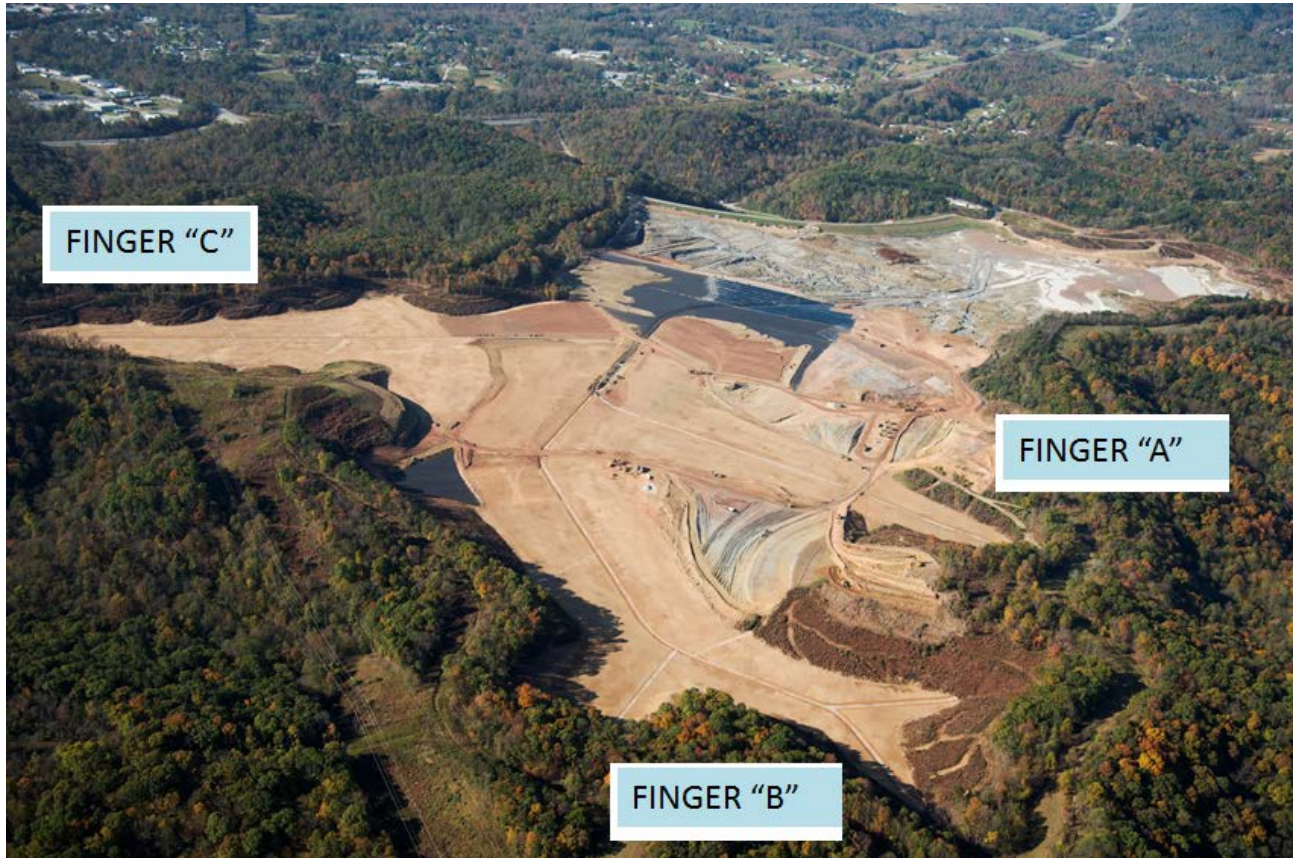
Figure 13. Progress of installation of cap system

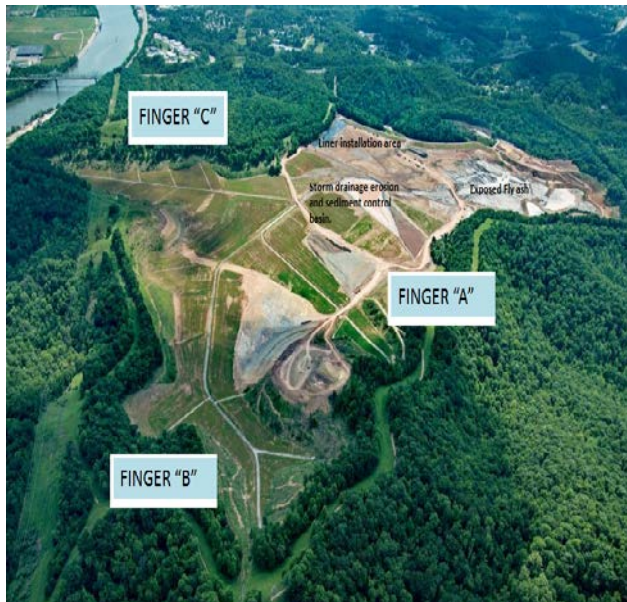
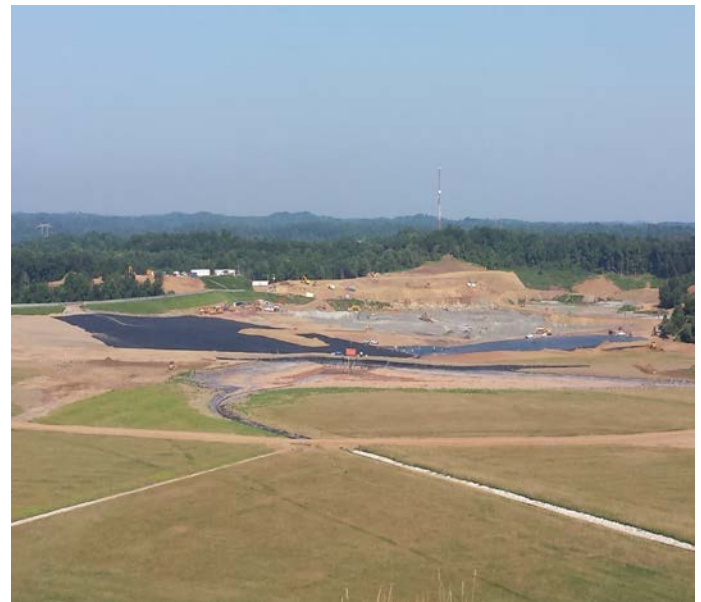
Figure 14. Completed cap system over fingers including erosion and sediment basin for non-contact storm water management, liner installation of middle section, exposed fly ash towards pumping system handling contact storm water.

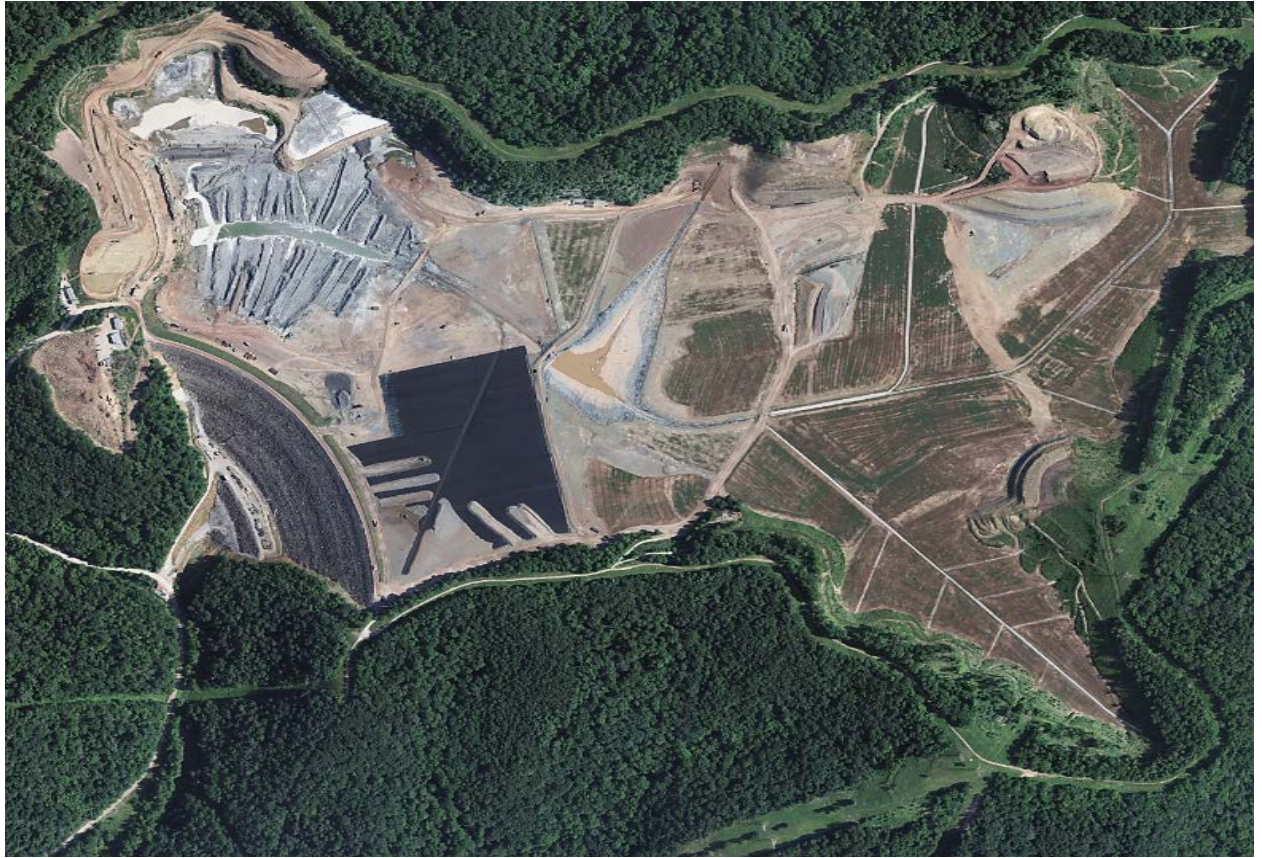
Figure 16. Work completed as of June 2016.
