Title – Closed Loop System for Coal Combustion Residual Dredging and Dewatering from A Recycle Pond with Landfill Placement

Authors: Jerry Vetter ¹, Eric Zeigler ²

Keywords – Coal Combustion Residuals Dredging, Dewatering, Landfill Placement, Water Treatment, Recycle Pond

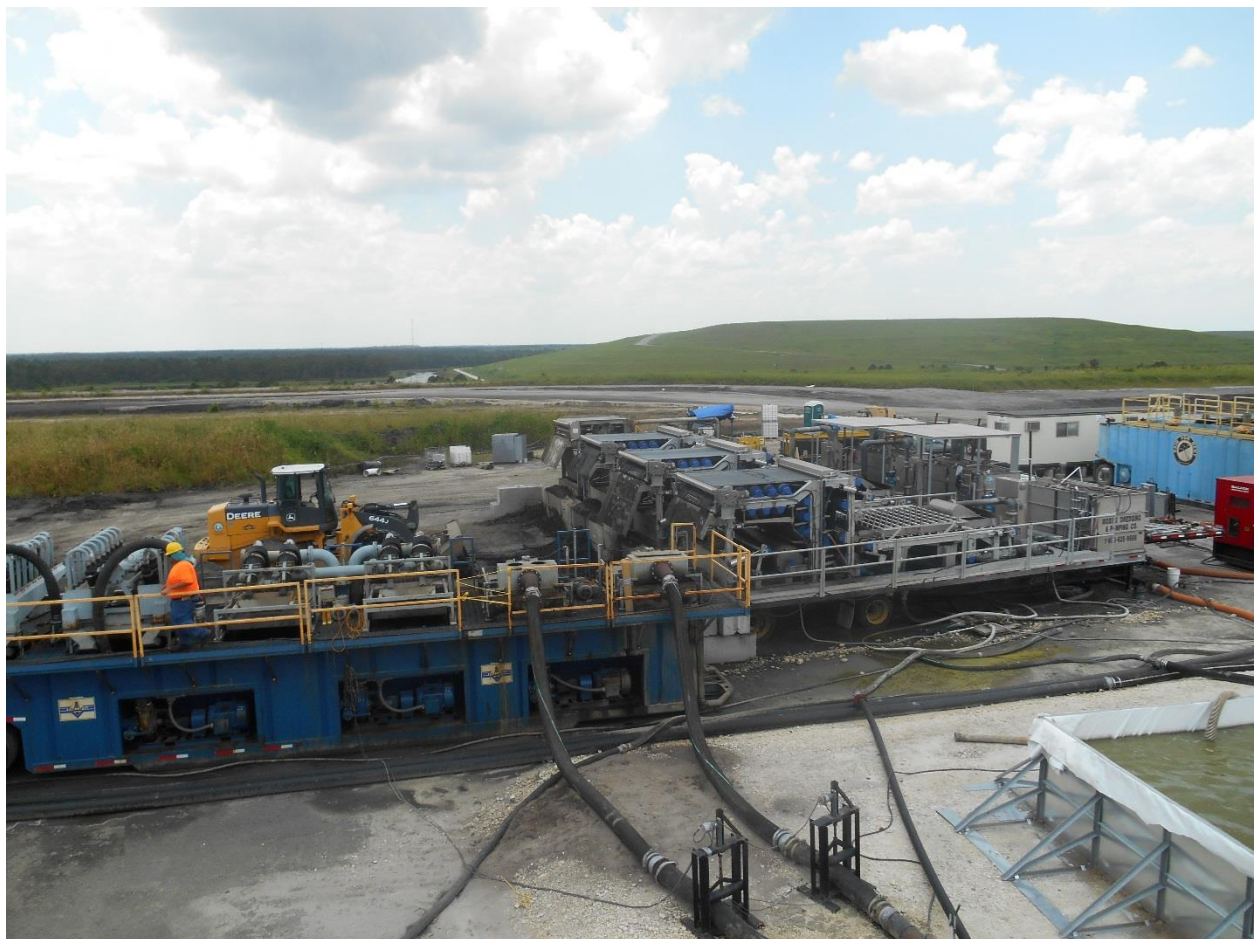
A photo of the dewatering process is shown below.

The dredge pumped the solids from the RB in a slurry through fuse welded 20 centimeters HDPE pipeline to a booster pump which pumped the slurry to a TriFlo 2000 unit at the dewatering equipment staging pad. The TriFlo unit separated the material into three phases for disposal using a series of pumps, screens and hydrocyclones. The coarse grained material was captured using hydrocyclones and dewatered on screens and discharged for loading into a stockpile. This dewatered material was placed to the west end of the staging area directly adjacent to our equipment staging pad.

An 80,000 liters mix/storage tank was placed in-line between the TriFlo unit and belt presses to provide a homogeneous feed to the dewatering equipment. This mix tank received the fine grained sediments which were not removed by screens and hydrocyclones. These fine grained sediments were conditioned with a polymer to enhance the dewatering process. Four trailer mounted 2.2 meter belt filter presses were utilized to dewater these solids and discharged into a stockpile to the west end of our staging area with a front end loader adjacent to our equipment staging pad. Power for the processing equipment was furnished by a 500KW diesel powered generator.

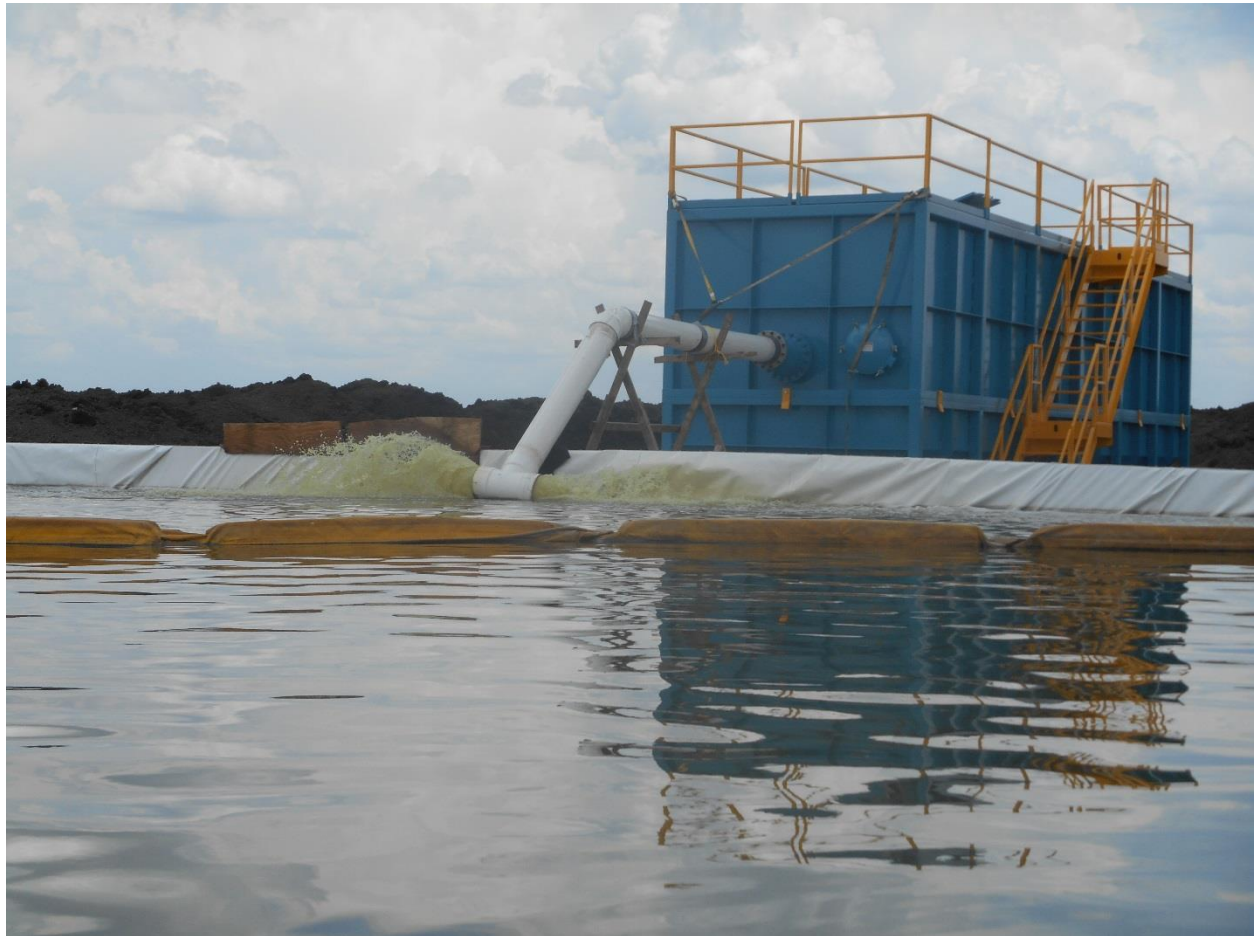
The filtrate from this stage of dewatering was discharged into a trailer mounted clarifier unit. Solids collected in the clarifier were returned to the belt filter press operation for dewatering. The filtrate from the clarifier was discharged into a lined 30 meter by 30 meter Modutank which was stationed adjacent to the dewatering equipment staging pad. The filtrate from the Modutank was discharged through a fuse welded pipe into the influent structure at the Landfill Leachate Pond for return to the RB. If TSS samples exceed 200 ppm, dewatering operations would be shut down until this limit could be achieved. A photo of the filtrate treatment process is below.
