Use of a CCP Grout to Reduce the Formation of Acid Mine Drainage: 10-Year Update on the Winding Ridge Project

Robin L. Guynn[1], Leonard G. Rafalko[1], Paul Petzrick[2]

[1]Environmental Resources Management, Inc., 200 Harry S Truman Parkway, Annapolis, MD 21401; [2]Maryland Department of Natural Resources, Power Plant Research Program, Tawes Office Building, B-3, Annapolis, MD 21401

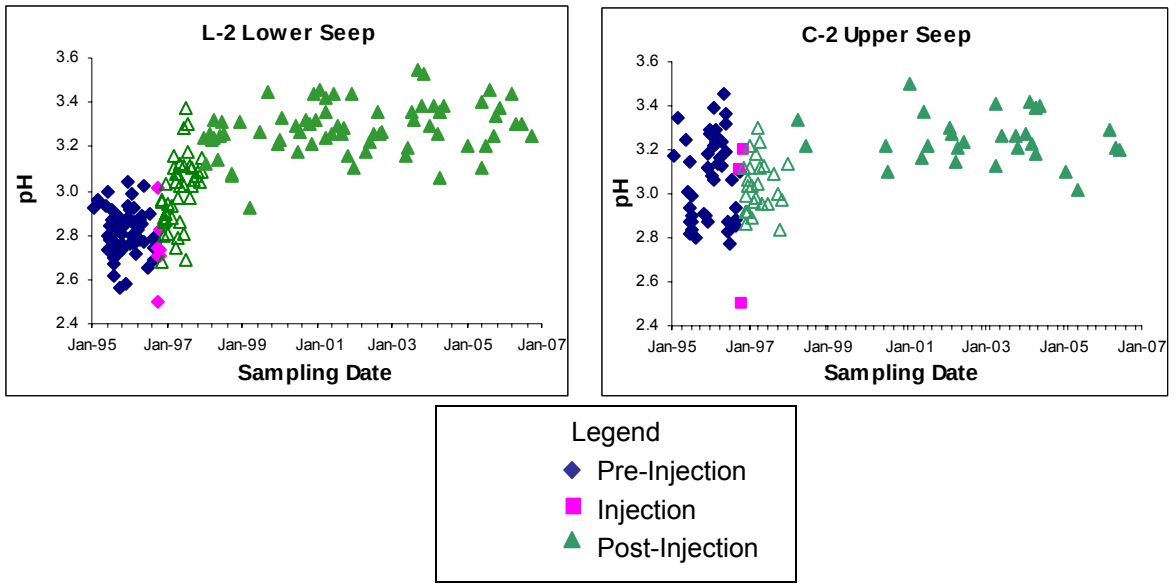
Figure 6
pH Results for Upper and Lower Seep at MO2

Figure 6 shows the measured pH values for the upper and lower seeps. At the lower seep, pH fluctuated within the historically observed range of values during and immediately after grout injection. Since injection, however, the lower seep pH has exhibited a beneficially upward trend, increasing by about 1 pH unit above pre-injection conditions. The upper seep has not shown any appreciable change in pH since injection. As mentioned above, this observation is attributed to the recharge of hydrogen ions to the mine water as the mine pool rises and falls, exposing pyritic strata to wetting and drying cycles.

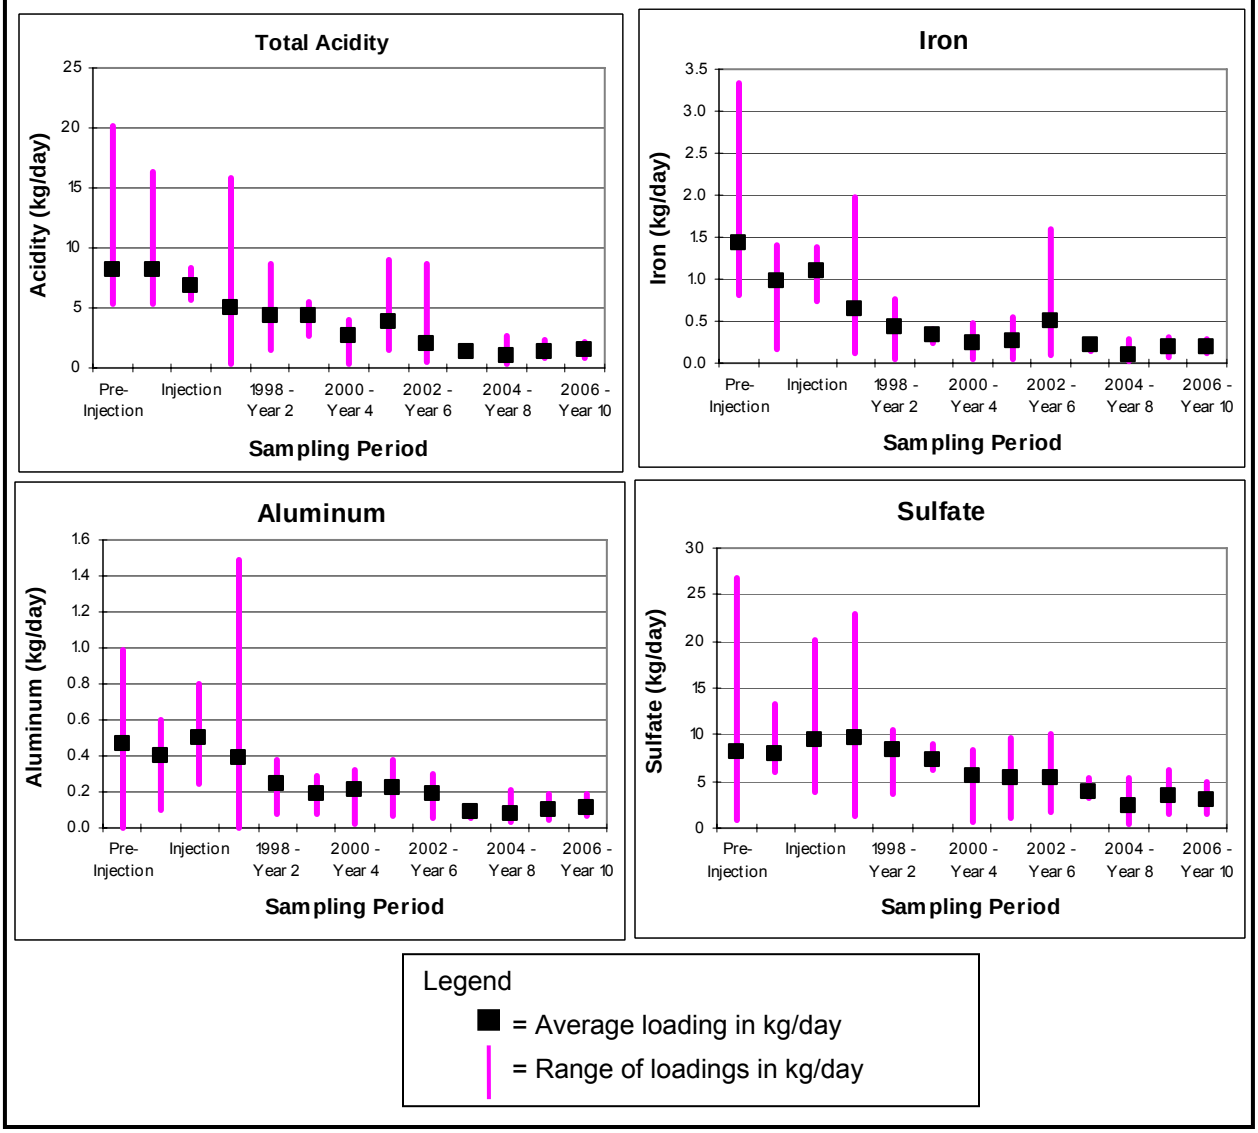
Figure 7
Loading ranges and Averages for AMD Parameters at MO2 Lower Seep

Figure 7 summarizes the loading of other AMD-related parameters (acidity, iron, aluminum, and sulfate) and calcium discharging from the lower seep over time. As noted previously, the flow rate from the lower seep has not changed since the pre-injection monitoring period. Any changes in the loading of any parameters in the mine discharge will be due to changes in the concentration of that parameter and not to

The results show a transient condition of mine water quality during the first year (November 1996 to September 1997) after grout injection. During this time period, the concentrations and loadings for AMD-related parameters increased significantly compared to pre-injection conditions. After that period, the concentrations and loadings gradually decreased to below pre-injection levels. The transient condition is probably due to a combination of factors. One contributing factor is that the grout injection phase could have indirectly caused a temporary increase in acidity when the mine pool was lowered as a result of pumping mine water for grout mixing. The lowering of the mine pool would have exposed previously submerged mine areas to oxidizing conditions,

which would have created acid weathering products available for mobilization once the mine pool rose to pre-injection levels. Another contributing factor could have been the re-routing of mine water through previously isolated mine workings. Nonetheless, the water quality data show that the transient condition was a relatively short-lived occurrence.

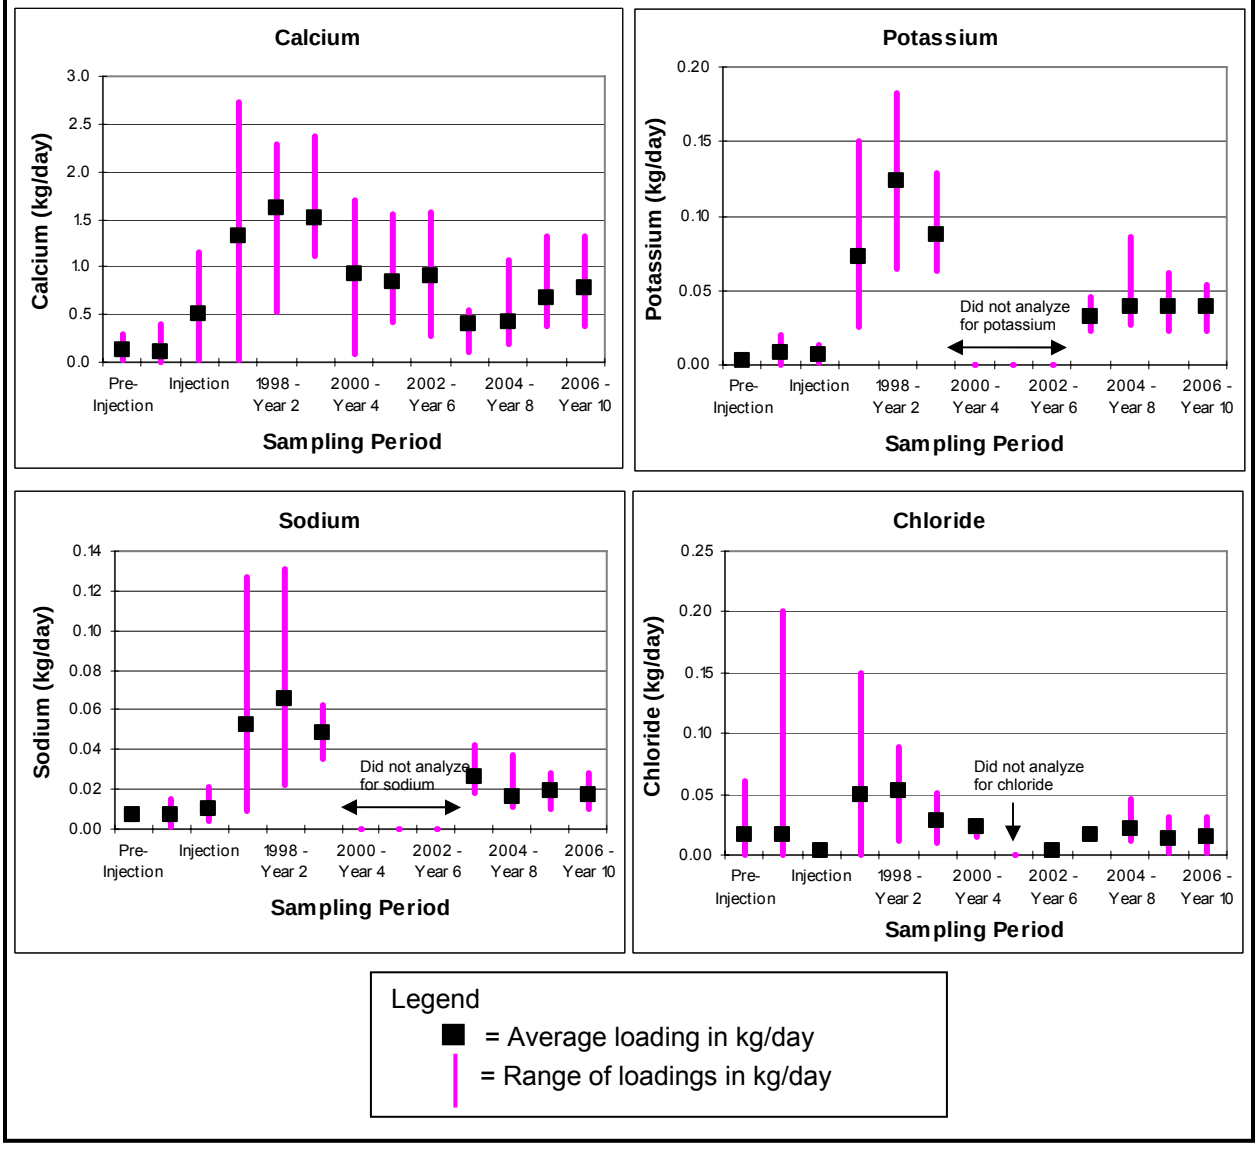
Figure 8
Loading ranges and Averages for Other Major Ions at MO2 Lower Seep

The post-injection loadings of calcium, potassium, sodium, and chloride remain elevated compared to pre-injection levels (Figure 8). These are non-toxic elements, and the post-injection concentrations for each of these elements in the mine discharge fall well below their average concentrations in sea water. The post-injection concentration of calcium is less than half of that in sea water (which contains about 400 mg/l calcium). The post injection concentrations of potassium, sodium, and chloride are one or more orders of magnitude below those in sea water (which contains about 400 mg/l potassium, 10,000 mg/l sodium, and 19,000 mg/l chloride).

Calcium, potassium, sodium, and chloride are most likely dissolving from the grout into the mine water. Part of the increase in sulfate loading observed during the transition period may also have been due to dissolution of grout components. However, since the grout cores from the mine show that the grout is strong, intact, and competent, dissolution is most likely localized to grout surfaces that are exposed to or in contact with acidic mine waters. In addition, though the levels of the non-AMD major ions remain elevated relative to pre-grouting levels, their concentrations in the mine discharge have gradually decreased in the ten years since injection. This suggests that dissolution rates are slowing. A reduction in the dissolution rate could be due to the formation of a low-solubility surface layer on the grout surface. Such a layer could be formed by the rapid dissolution more soluble grout components from the grout surface, leaving a layer of less soluble grout components, which could behave as a low permeability crust preventing water from reaching the rest of the grout. Another contributing factor could be precipitation and coating by secondary minerals (i.e. iron and aluminum hydroxides) on the grout surface as the chemical conditions within the mine tunnel change.

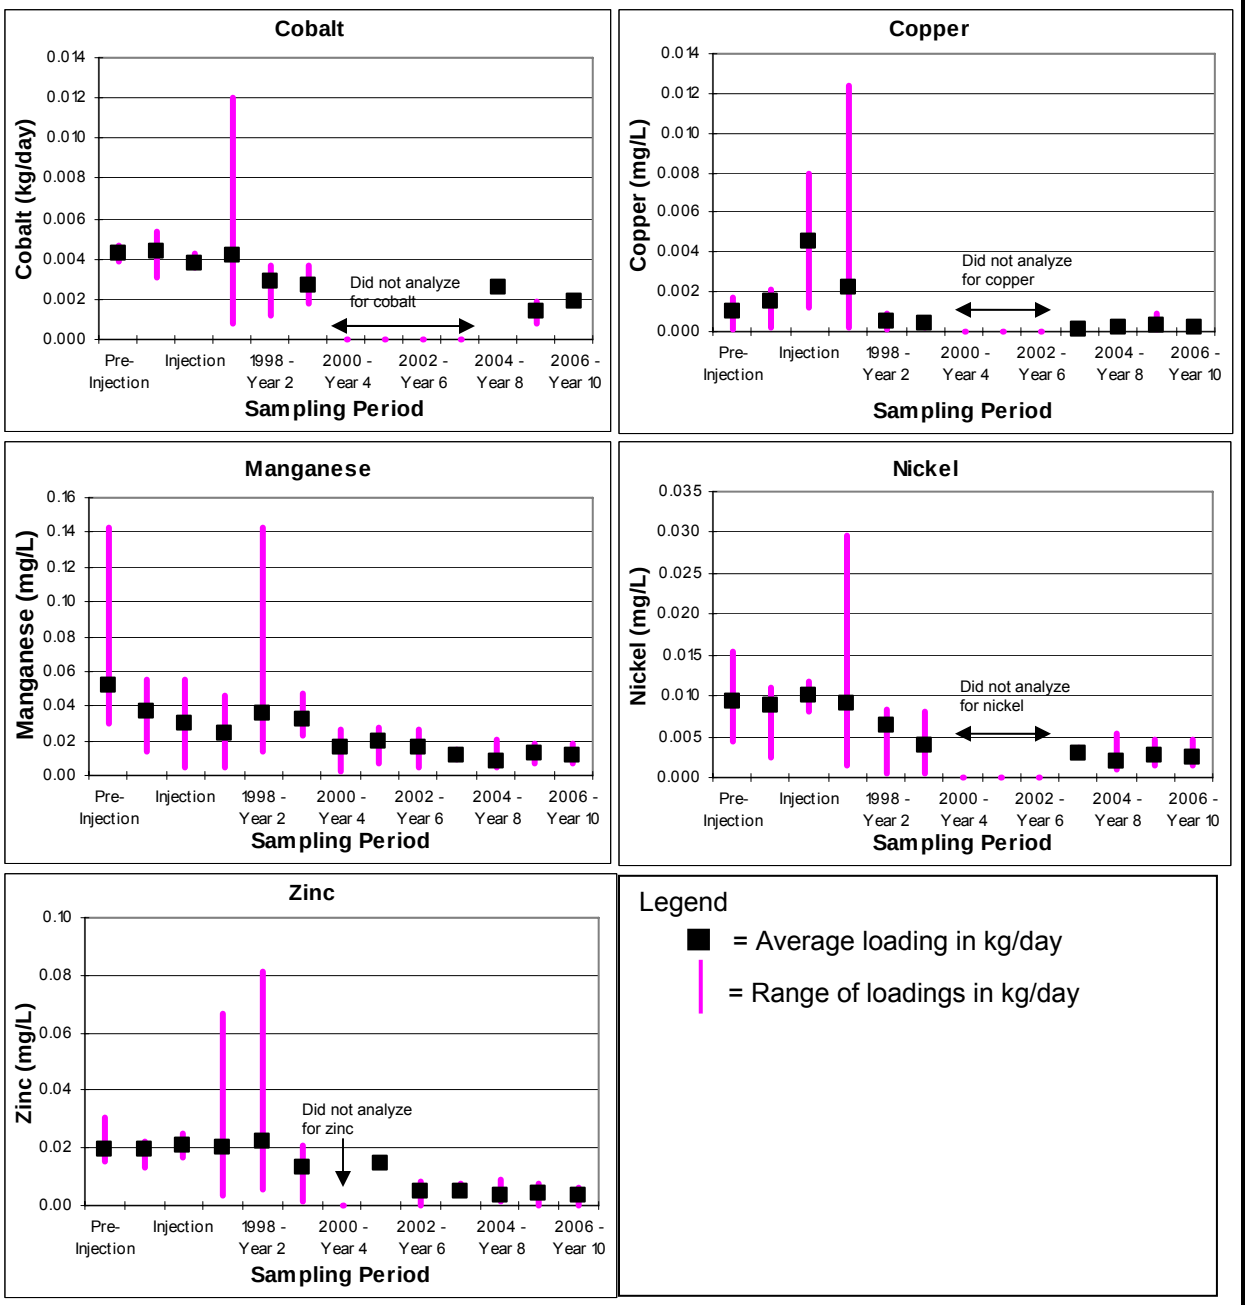
Figure 9
Loading Ranges and Averages for Trace Metals at the MO2 Lower Seep

Figure 9 summarizes the loading data for copper, cobalt, nickel, manganese, and zinc. As with the AMD-related parameters, the plots show a transition period of elevated concentrations and loadings during the first year after grout injection. Since the second year after grout injection, however, the trace elements concentrations and loadings have consistently fallen within or below those observed prior to injection. In particular, the concentration of copper has fallen to the point that it is often reported as below detection levels in the mine discharge samples.

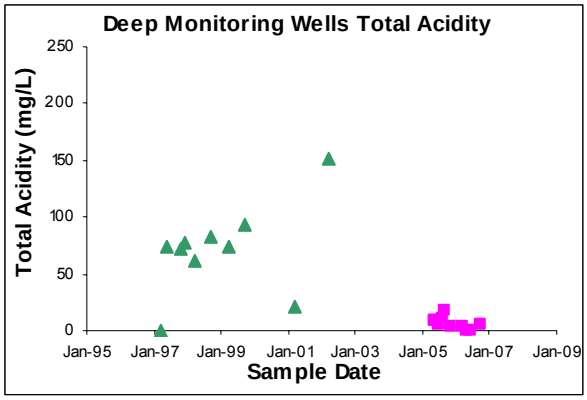
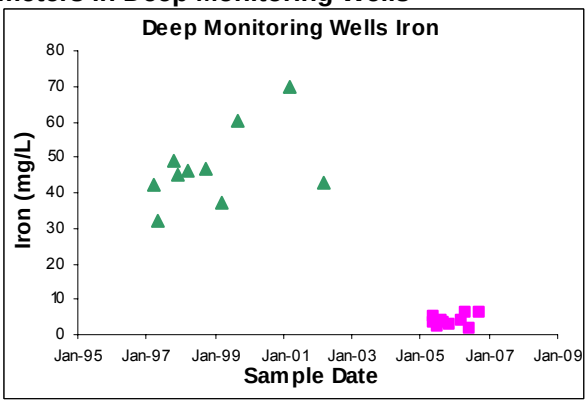
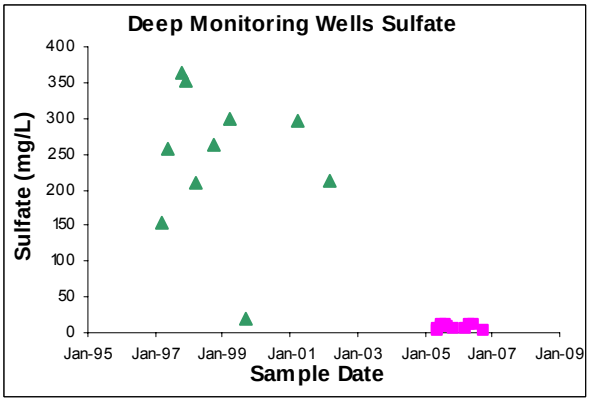
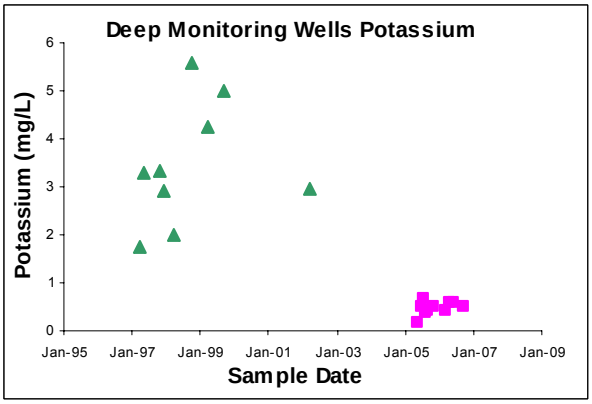
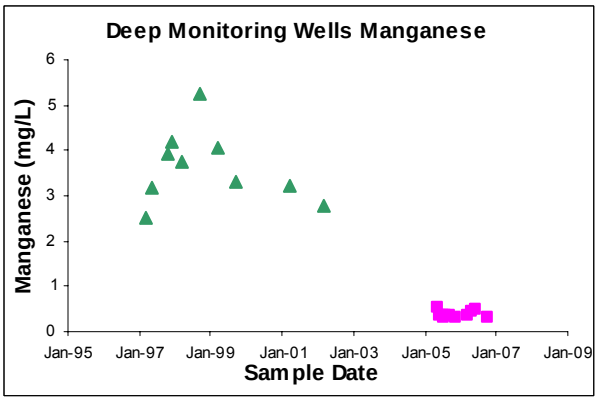
Figure 10
Concentration of Selected Parameters in Deep Monitoring Wells

For the most part, the deep ground water data are unremarkable, however it is worth noting that some parameters at monitoring well MW-4D are elevated when compared with the same parameters at well DUG-1. The concentrations of acidity, iron, sulfate, potassium, and manganese are consistently higher at MW-4D than at DUG-1 (Figure 10). Because there is no pre-injection data for the deep wells, it is not certain that these differences are related to grout injection or possibly to vertical leakage of AMD through the bedrock to deeper ground water that may have occurred prior to injection. It does appear, however, that deep ground water quality may have been impacted by AMD and/or by grout constituents. It also appears that the impact, if present, is minor.

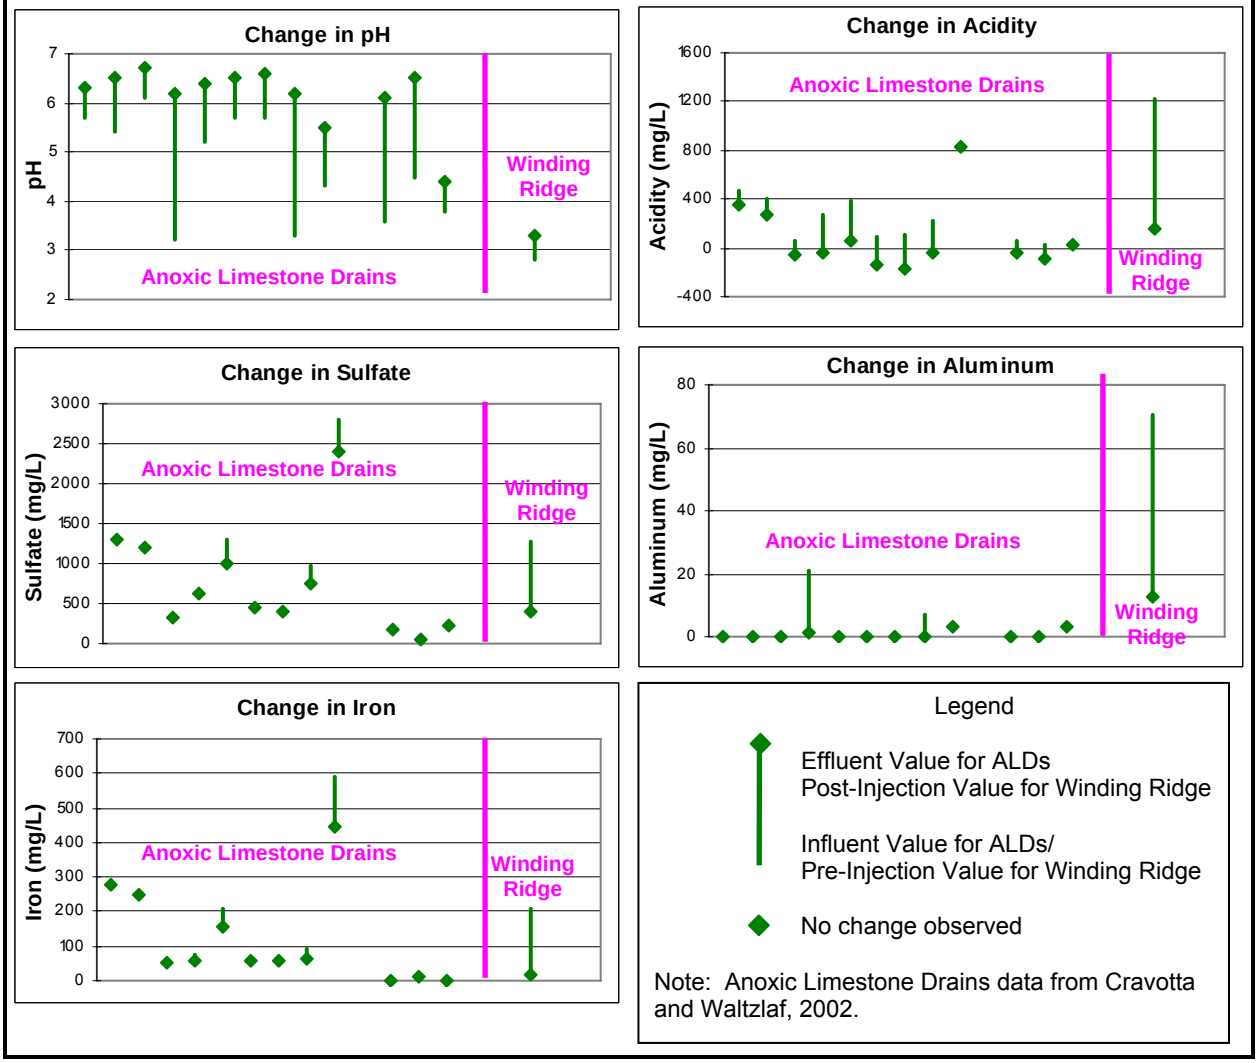
Figure 13
Comparison of Winding Ridge Grout Injection to ALDs

Figure 13 summarizes the total changes in water quality observed at the lower seep at Winding Ridge compared with published changes in water quality observed for AMD that has been treated using ALDs[5]. The bars for Winding Ridge represent long-term changes (average pre-injection concentrations vs. average 2006 concentrations) whereas the ALD bars represent the average quality of water entering the ALD vs. the average water quality exiting the ALD.

While the Winding Ridge project has not achieved the increases in pH or alkalinity observed with most of the ALD systems, the Winding Ridge project has, over time, achieved much more significant reductions in acidity, sulfate, iron, and aluminum than typically observed at ALD systems. It should be noted again that high concentrations of aluminum, such as those observed at the Winding Ridge site are problematic for ALD systems due to armoring. The grouting approach used at Winding Ridge is not susceptible to this type of failure.
