CONDITIONS OF COAL ASH EMBANKMENTS

**John Seymour¹, P.E., Omer Bozok¹, Amanda Hughes¹, Ph.D.,
Brad Bodine¹, P.E., CHMM**

CONFERENCE: 2015 World of Coal Ash – (www.worldofcoalash.org)

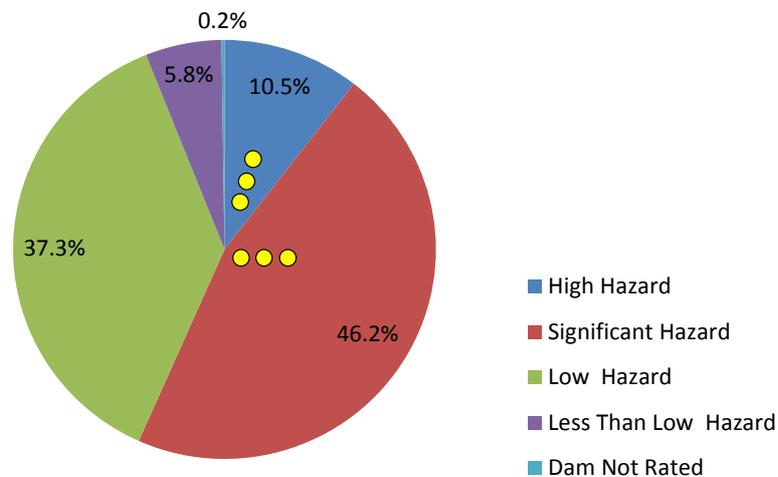
The hazard potential classifications of embankments described in the Reports are as follows: 45 (10%) high, 198 (46%) significant, 160 (37%) low, and 25 (6%) less than low (Figure 1). One embankment was not rated. Three of the embankments that had previously failed were classified as posing a significant hazard and three were classified as high hazard.

Figure 1. Hazard potential classifications of embankments. Yellow circles indicate the category of failed embankments.

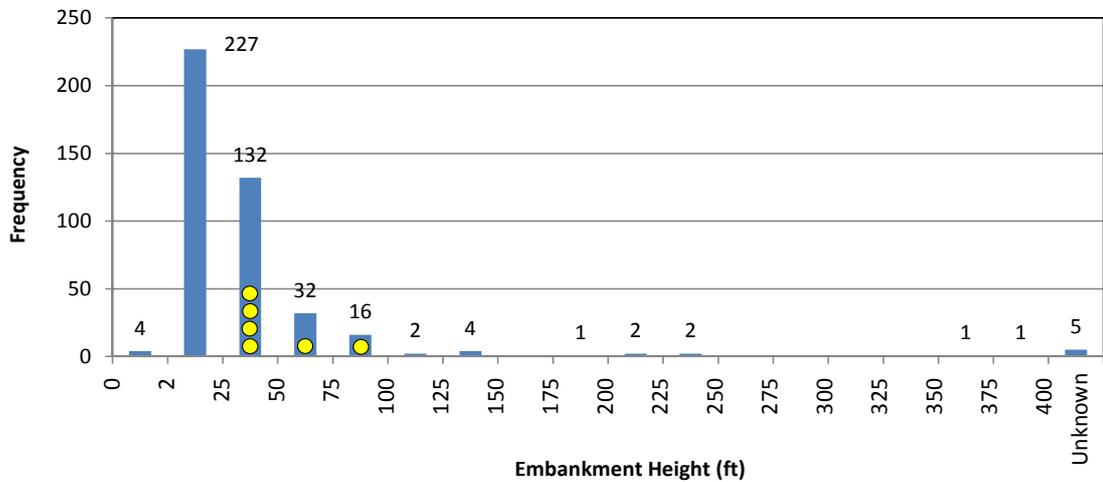
Histograms for embankment heights for all impoundments are provided in Figure 2. The tallest embankment (400+ feet) is at the FirstEnergy Little Blue Run impoundment. The results indicate the majority of the embankments had a height greater than 2 feet and less than or equal to 25 feet (227 embankments, 53%), and greater than 25 feet and less than or equal to 50 feet (132 embankments, 31%). The heights of the six embankments which have previously failed ranged from 28 feet to 85 feet, with four embankments in the 25 to 50 foot range, one embankment in the 50 to 75 foot range, and one embankment in the 75 to 100 foot range.

Figure 2. Embankment height. Yellow circles indicate the category of failed embankments. Bins are inclusive of their maximum value (e.g. 227 embankments have heights that are greater than 2 and less than or equal to 25 feet).

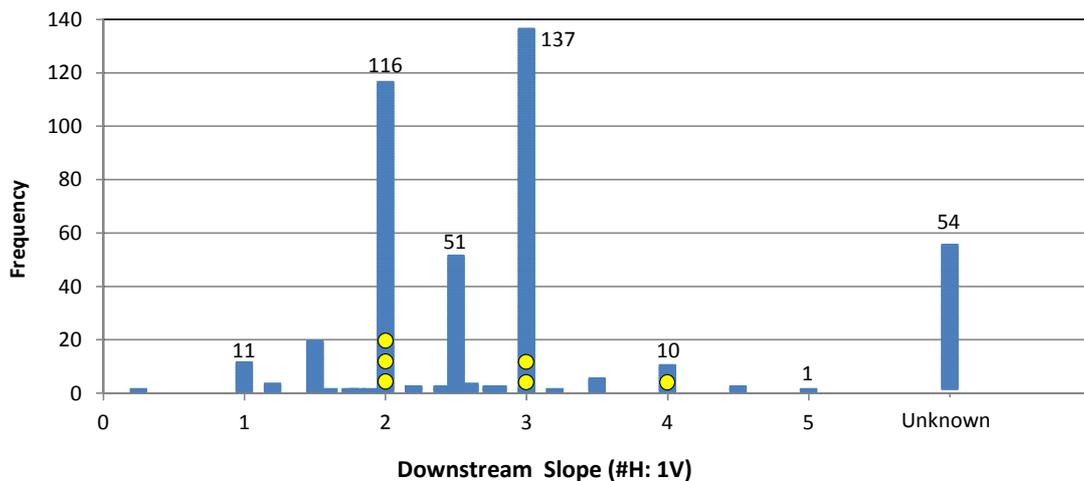
Reported downstream slopes of embankments ranged from 0.25H: 1V to 30H: 1V (Figure 3). The downstream slopes of 54 embankments were not described in the Reports. The median slope was 2.5H: 1V, the average slope was 2.67H: 1V, with a standard deviation of 2.3. Of the six embankments that previously failed, three had slopes of 2H: 1V, two had slopes of 3H: 1V, and one embankment had a slope of 4H: 1V.

Figure 3. Histogram of downstream slope (#H:1V) of embankments. Yellow circles indicate the category of failed embankments. Three embankments with slopes greater than 5H:1V are not shown.

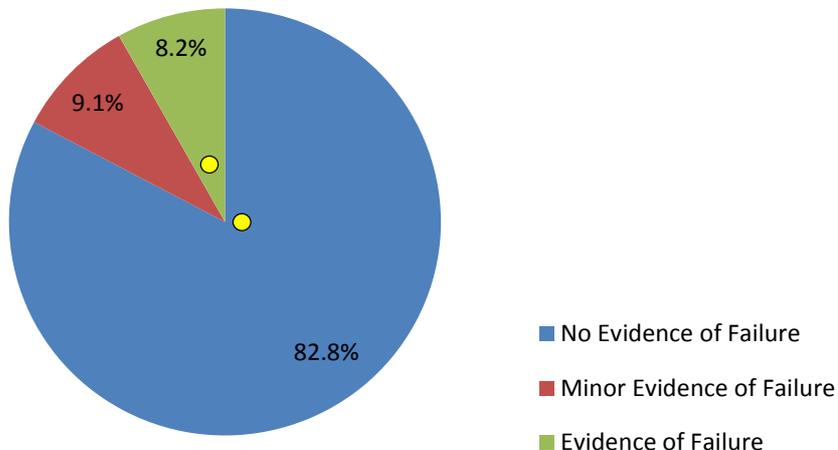
Only *evidence of failures* that may lead to failure is included; the data exclude the six failed embankments or facilities if a feature other than the embankment failed. Four of the failed facilities occurred before the inspection and are excluded. The results indicate that a minor or significant failure has occurred at 73 (17%) of the reviewed CCR impoundments (Figure 5). The remaining 83% of embankments are reported to have no evidence of failures. One embankment (Primary Ash Storage Basin at the Dan River Steam Station) failed after the inspection. USEPA inspections for the five remaining embankments that failed prior to the USEPA inspections had evidence of failures that was not related to the more significant previous failure.

Figure 5. Evidence of failure of embankments.
Yellow circles indicate the category of failed embankments.

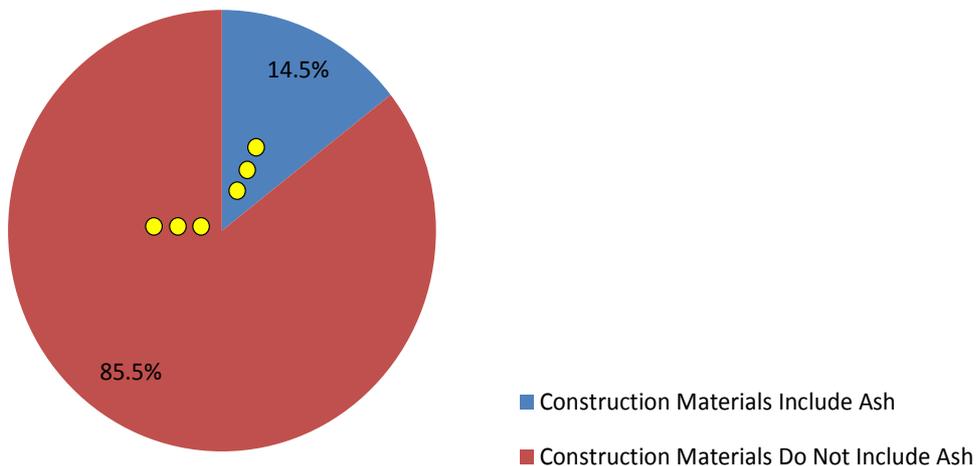
The construction materials of 62 (14.5%) of the embankments reviewed are either entirely or partially of ash (Figure 6). The remaining 367 embankments reviewed (86.5%) are earth embankments and did not include ash. Three of the six embankments that previously failed contained ash.

Figure 6. Embankment dike construction materials.
Yellow circles indicate the category of failed embankments.

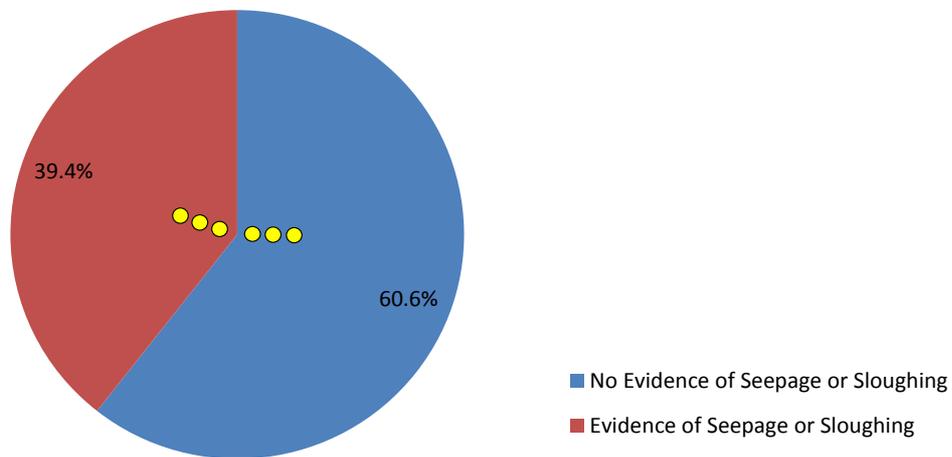
Evidence of seepage was present at approximately 40% (171 embankments) of the reviewed impoundments, including five embankments that previously

failed (Figure 7). The remaining 60% of embankments (258) had no evidence of seepage or sloughing.

Figure 7. Evidence of seepage or sloughing observed on embankments. Yellow circles indicate the category of failed embankments.

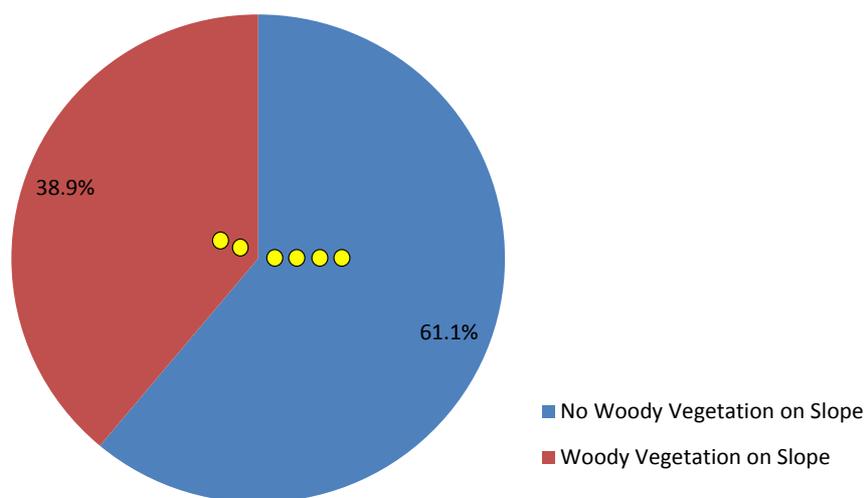
Woody vegetation was present on 167 (39%) of the embankments having Reports, including two embankments (Secondary Fly Ash Pond at Baldwin Power Station and the Gypsum Stack Embankment at Widows Creek Fossil Plant) that had previously failed (Figure 10). The remaining 262 embankments reviewed (61%) were reported to not have woody vegetation present on the slopes.

Figure 10. Woody vegetation on embankment slope. Yellow circles indicate the category of failed embankments.

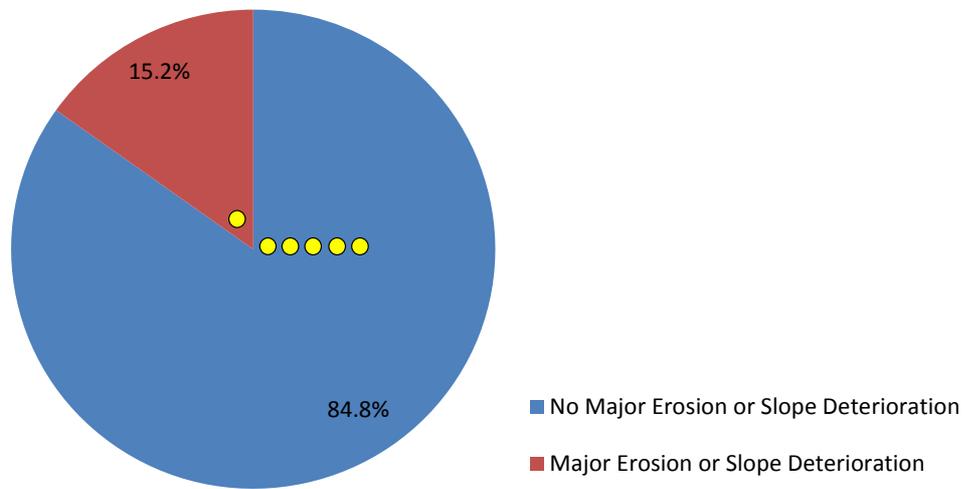
The majority (364, 85%) of the embankments described in the Reports were reported to not have major erosion or slope deterioration (Figure 12). Five of the six embankments that previously failed reported no major erosion or slope deterioration; we have made the assumption that this condition was reflective of the failed facilities at the time of failure. The remaining 65 (15%) of the embankments reviewed reported major erosion, including one of the embankments that had previously failed.

Figure 12. Major erosion or slope deterioration on embankment. Yellow circles indicate the category of failed embankments.
