# Preparing for Closure of the John Sevier Fossil Plant: Re-Routing of the Bottom Ash Pond Outfall Driven by NPDES Requirements

KEYWORDS: NPDES, pond, closure, discharge, outfall

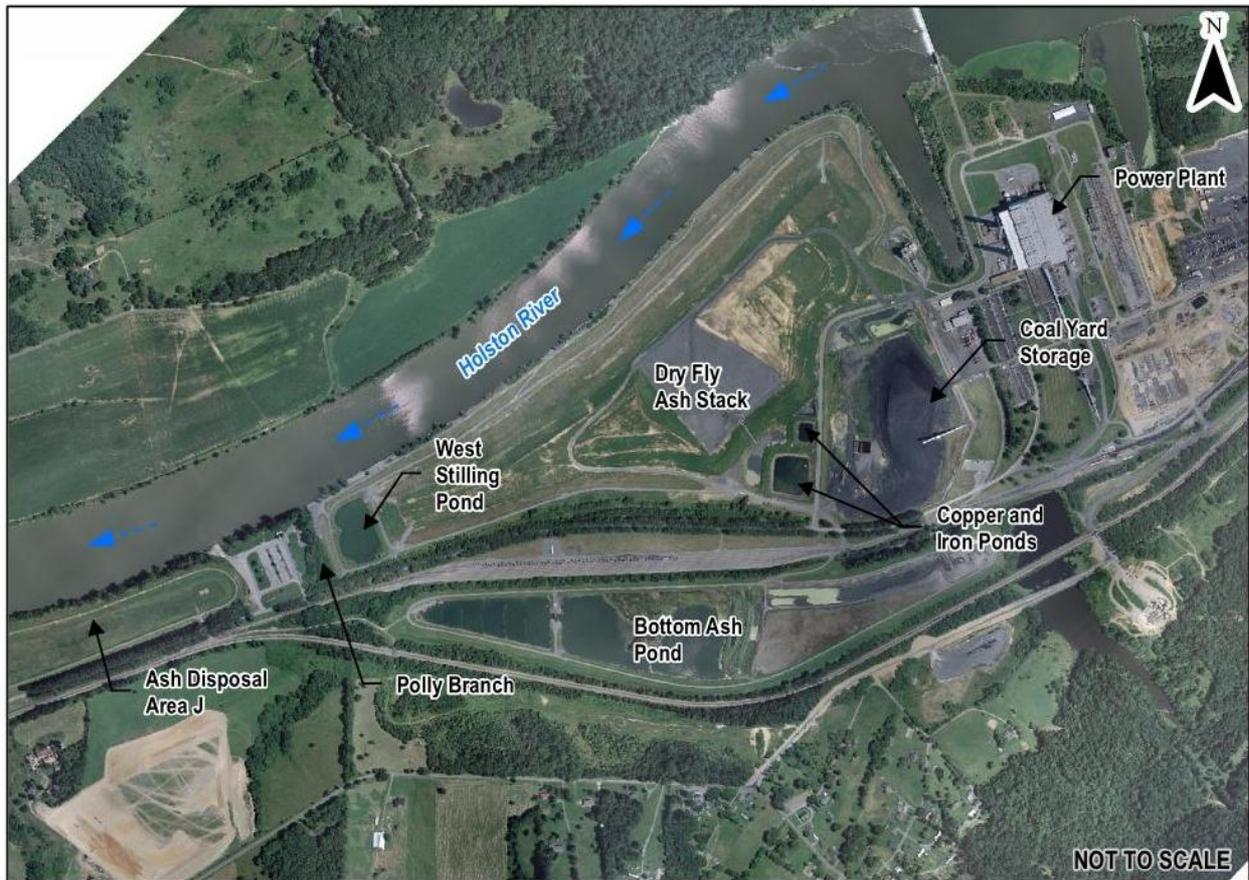
Figure 2. John Sevier Fossil Plant Overview Map

Ash Disposal Area J (previously closed). Figure 2 shows the layout of the three facilities along with other ancillary structures.

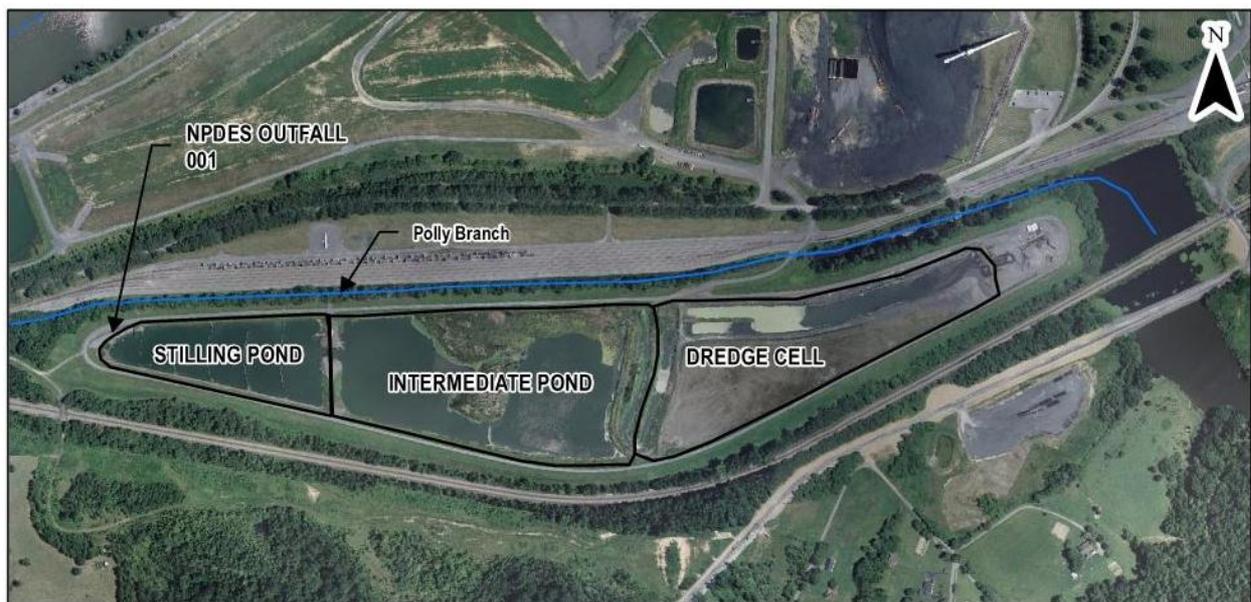
Figure 3. Bottom Ash Pond Sub-Areas

This 42-acre (170,000-square meter) structure was formed by constructing an 8,600-foot (2,621-meter) long earthen dike, measuring approximately 20 feet (6.1 meters) in height and with a 16-foot (4.9-meter) wide crest. For the purposes of planning closure and restoration, the BAP may be considered to include three sub-areas located from east to west (Figure 3):

- Sub-Area 1: Dredge Cell. This sub-area contains principally bottom ash that settled during initial hydraulic deposition in the BAP as well as lesser amounts of finer grained ash dredged periodically from other sub-areas of the BAP and consolidated in this sub-area.
- Sub-Area 2: Intermediate Pond. This sub-area contains finer grained ash that settled more slowly during hydraulic deposition.
- Sub-Area 3: Stilling Pond. This sub-area is used for gravity polishing of water prior to release from the BAP through Outfall 001.

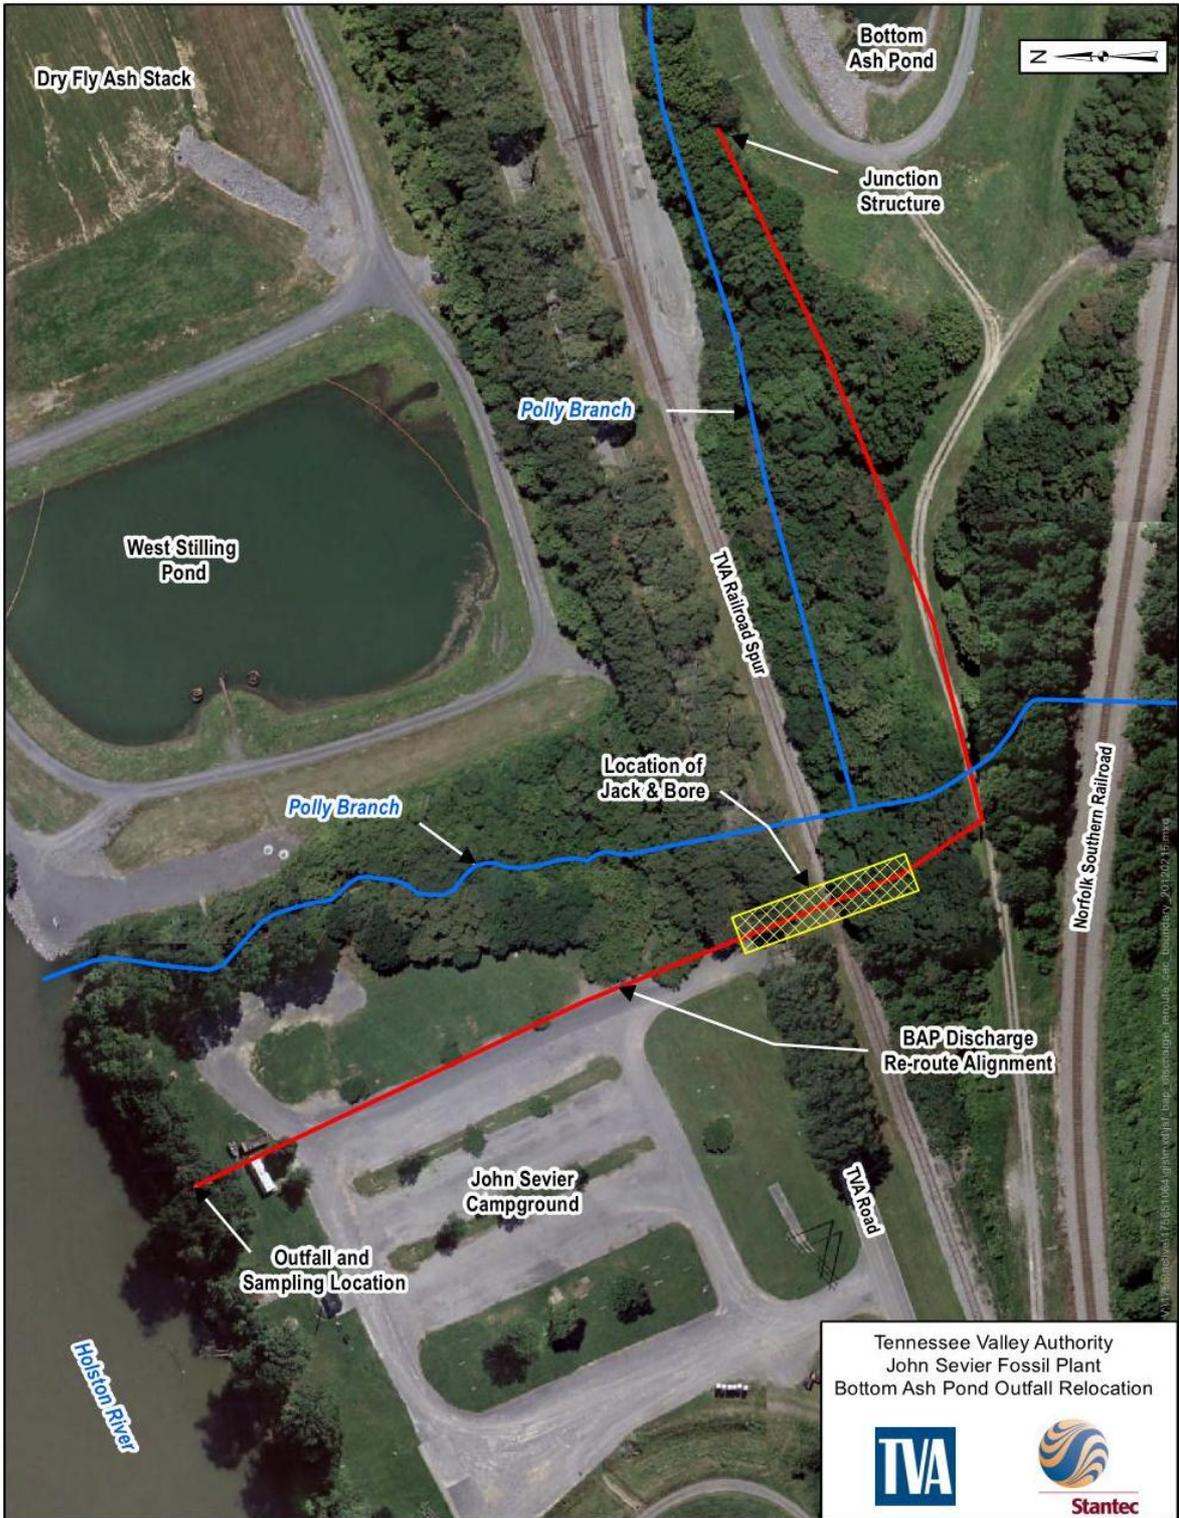
Figure 4. Selected BAP Discharge Re-Route Alignment

The constructed alignment is approximately 1,400 feet (427.8 meters) in length, as shown in Figure 4. From the existing BAP outfall location, it exits through the west wall of the proposed junction structure towards a hillside covered with brush and trees. The alignment veers towards the south and passes through a gently sloping ridge. The alignment follows an existing unimproved road and crosses over two parallel 60-inch (152.4 cm) corrugated metal pipes (CMP). Shortly after passing over the two CMPs, the alignment makes an approximate 90 degree bend, crosses perpendicular to a swale (which drains to Polly Branch), and then crosses under the railroad tracks, and TVA Road. The pipe was advanced underneath the railroad and TVA Road by bore and jacking. On the north side of TVA Road, the alignment crosses under an existing underground electric line, an existing 18-inch (45.7 cm) CMP culvert and a 15-inch (38.1-cm) reinforced concrete pipe (RCP) storm sewer. The alignment continues to the Holston River and discharges through a headwall at elevation 1,078.3 feet (328.7 meters) mean sea level (MSL).
