# Long-Term Permeability Monitoring of an FGD-Lined Pond Facility

Tarunjit S. Butalia<sup>1</sup>, William E. Wolfe<sup>1</sup>, and Harold Walker<sup>1</sup>

<sup>1</sup>Department of Civil and Environmental Engineering and Geodetic Science, The Ohio State University, 470 Hitchcock Hall, 2070 Neil Avenue, Columbus, Ohio 43210

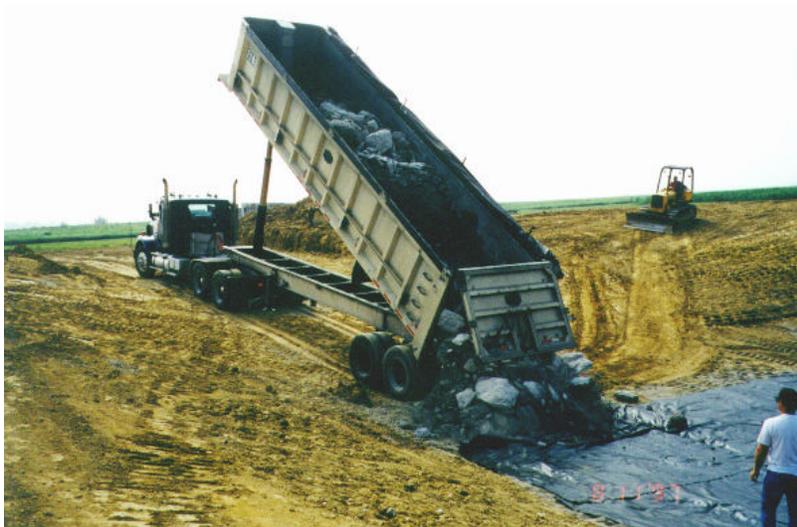
Figure 1. Truck Unloading FGD Material

Lime and fly ash enriched stabilized FGD material was delivered by truck (starting August 11, 1997) from American Electric Power's Conesville Station near Coshocton, Ohio to the site (refer to Figure 1). Placement and compaction of FGD in 4-6 inch lifts on top of the geofabric layer were accomplished using two dozers and one sheepsfoot roller (see Figures 2 and 3). Approximately 2,700 tons of lime-enriched stabilized FGD material was used in the construction of the primary liner. The fly ash to filter cake ratio of the FGD material ranged from 1.48:1 to 2.40:1 with an average ratio of 1.81:1. The lime content varied from 6.79% to 8.44% with an average lime content of 7.98%. The

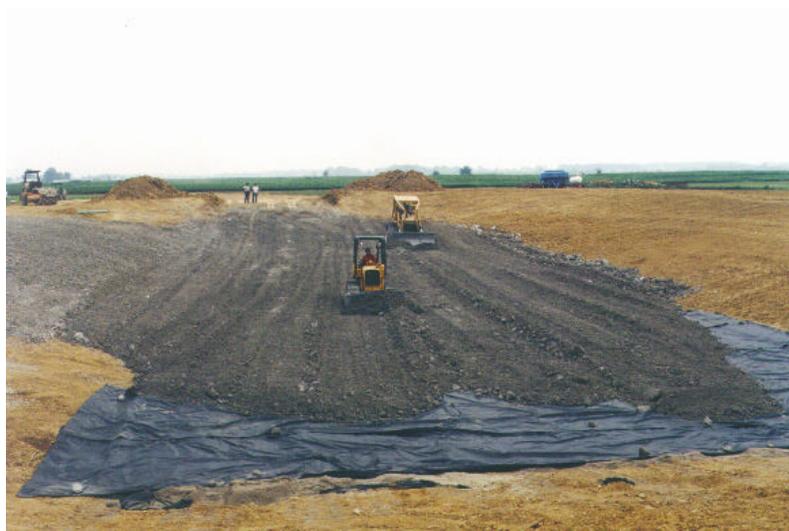
Figure 2. Spreading the FGD Material

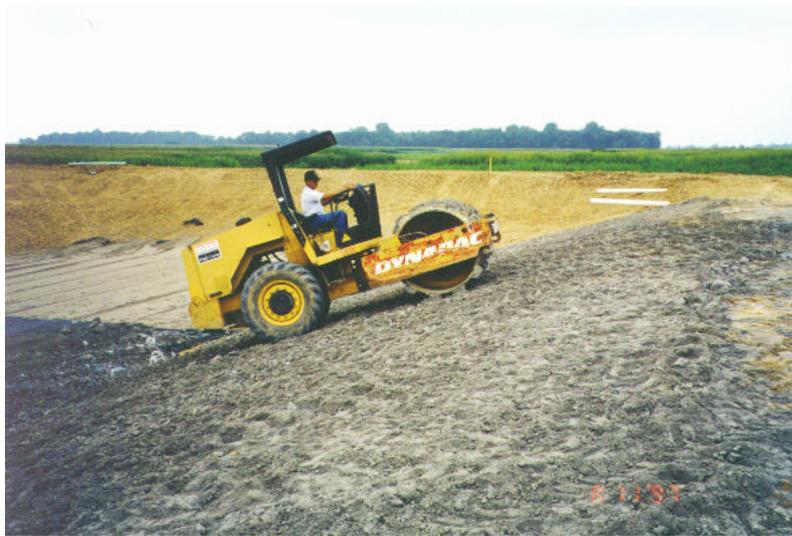
Figure 3. Compacting FGD Material on a Side Slope

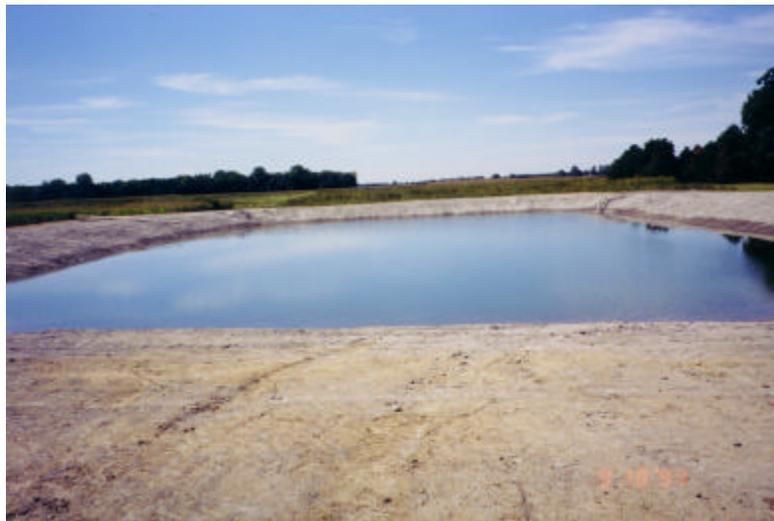
Figure 4 Facility Filled With Water

moisture content of the FGD material received at the site during construction ranged from 49% to 62%, while the proctor dry density varied between 9.6 and 11.6 kN/m<sup>3</sup>. Wet weather during the liner placement resulted in several delays but construction at the site was completed by August 26, 1997. The site was smooth rolled before completion of the project. Filling of the pond with water from an existing nearby pond began on September 12, 1997 and was completed on September 23, 1997. The pond was filled with water up to a depth of approximately 9 feet as shown in Figure 4.

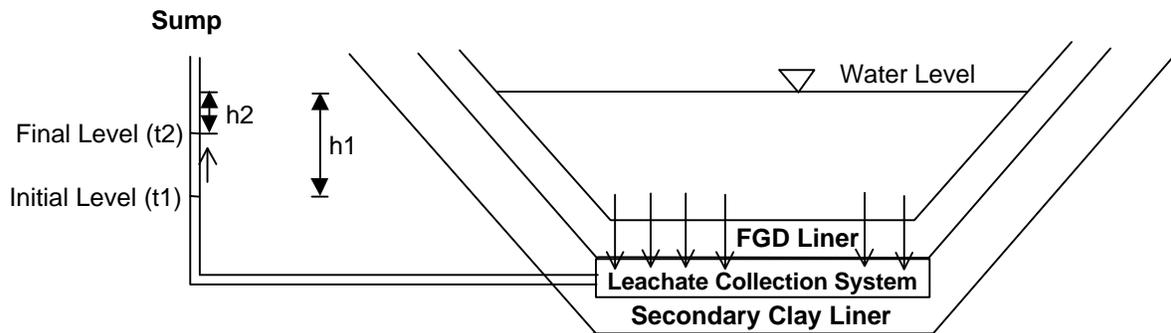
$$k = \frac{L}{(t_2 - t_1)} \frac{a}{A} \ln\left(\frac{h_1}{h_2}\right)$$

L = Thickness of FGD liner  
a = Area of sump  
A = Effective area of FGD liner

Figure 5 Full Scale Permeability Test (not to scale)

- 1) *Field Permeability Testing*: Full-scale falling head permeability tests on the facility were conducted by lowering the water level in the sump to create a head difference across the FGD liner. The amount of time taken to increase the water in the sump to specific levels was observed. Knowing the thickness of the FGD liner and its plan view area, the effective permeability of the field compacted FGD-lined facility was calculated (refer Figure 5).

After filling the full-scale facility with water, the actual field permeability of the FGD liner was measured by lowering the water level in the sump and taking readings of the water level rising in the sump at various time intervals (refer to Figure 5). The permeability coefficients were calculated using the bottom area of the pond as the effective leaching area for the FGD-liner. Table 2 shows the effective coefficients of permeability obtained from full-scale permeability tests conducted on the pond facility. The permeability coefficient values listed in Table 2 are the average of several test readings that were measured at each curing time. The full-scale permeability of the facility was evaluated to be  $9.1 \times 10^{-7}$  cm/sec at a curing time of one month. The permeability coefficient continued to reduce over time (due to curing of FGD) and has stabilized at approximately  $4 \times 10^{-7}$  cm/sec. The FGD permeability coefficient data range obtained from the full-scale tests is comparable to typical clays used in the construction of compacted liners. The data presented in Table 2 includes the effect of freeze-thaw cycling on the actual permeability of the FGD liner. The actual area over which water flows through the FGD liner is greater than the bottom area of the pond (i.e., a significant amount of water may flow through the sides of the pond). Hence the full-scale permeability values presented in Table 2 should be taken to be an upper bound to the actual permeability of the field-compacted FGD liner. The addition of swine manure to the facility (at 370 days of curing and thereafter) did not affect the actual permeability of the liner.

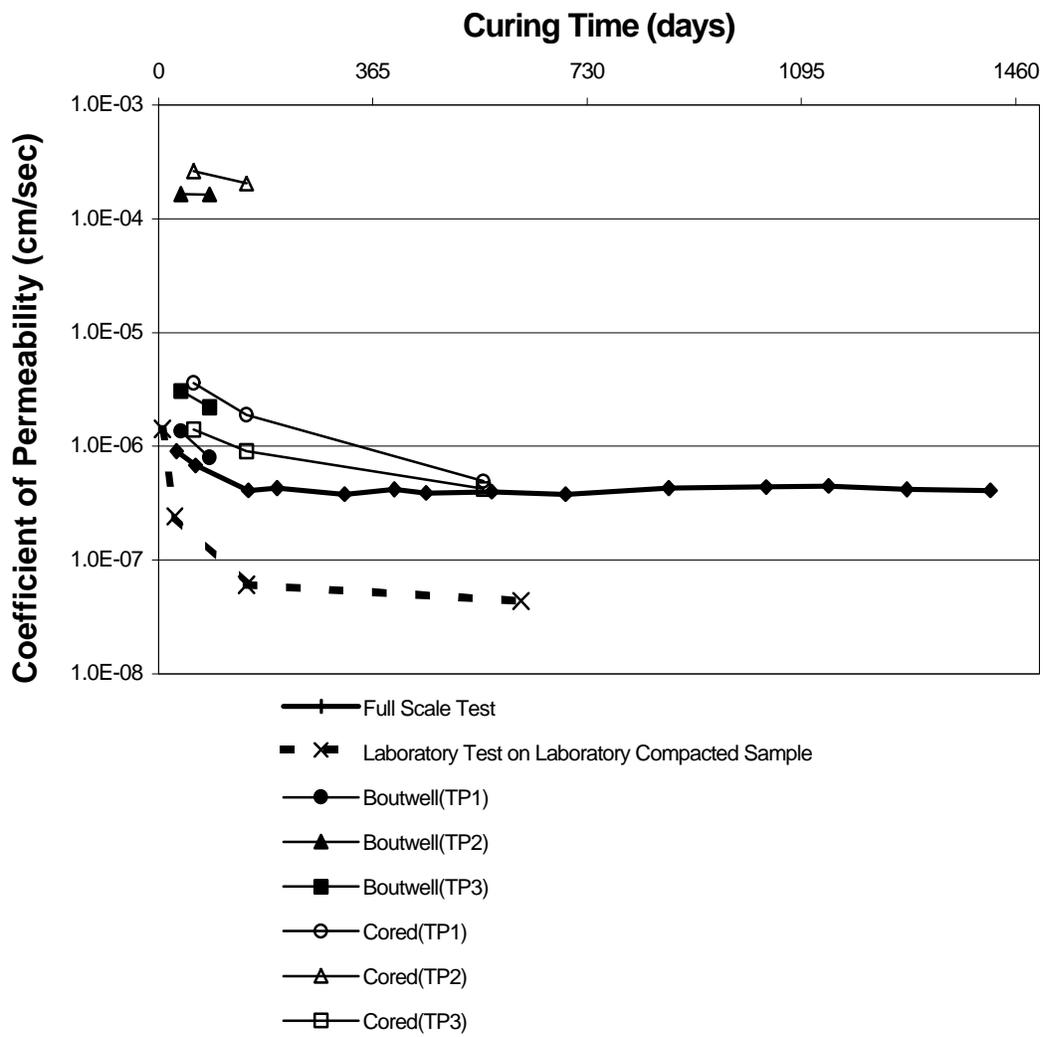
Figure 6. Comparison of Permeability Test Methods

The actual field permeability data obtained from the full-scale pond tests was compared with a) laboratory tests conducted on several laboratory compacted samples collected during pond construction, b) laboratory tests conducted on field compacted samples cored from test pads installed at the site, and c) field permeability tests (Boutwell) conducted on the test pads TP1, TP2, and TP3. TP4 was not considered for comparison because this test pad was constructed using FGD material that was lower in lime content and fly ash to filter cake ratio compared to the material used in the construction of the full-scale facility. Figure 6 shows the time history comparison of the full-scale permeability test values with averaged permeability coefficients obtained from a) laboratory tests on laboratory compacted samples, b) field tests (Boutwell) conducted on test pads, and c) laboratory tests conducted on samples cored from test pads. All the test procedures showed decreasing permeability coefficient with increasing curing time. It was observed that the laboratory compacted samples had permeability coefficients which were an order of magnitude lower than the full-scale testing values. Permeability values obtained from Boutwell tests and cored samples tested in the laboratory were in close agreement with each other but were one to three orders of magnitude higher than the full-scale tests. The test pad sample permeability values (Boutwell tests and cored sample testing) indicated a large scatter in the data. The permeability coefficients varied from  $10^{-4}$  to  $10^{-7}$  cm/sec with average permeability value in range of  $10^{-5}$  cm/sec. This may be due to the unsuitable compaction achieved for the test pads. Furthermore, the Boutwell test procedure relates infiltration rate with permeability coefficient by assuming certain direction and boundary conditions of flow, which are nearly impossible to control in the field. However, it is important to note that the actual measured field permeability values of the full-scale FGD liner are an order of magnitude higher than laboratory measured values.
